**CAMBRIDGE CROSSINGS
HOMEOWNERS ASSOCIATION
SOUTHPORT, NC.**

May 25, 2022

FULL RESERVE STUDY

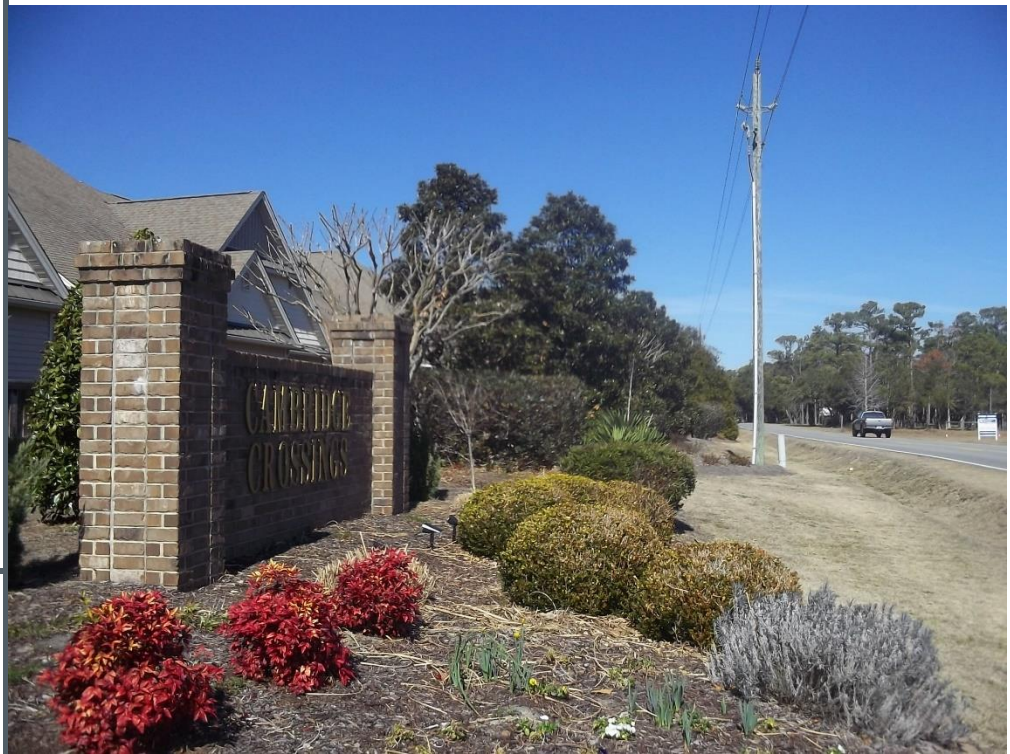
Photo No.
1

View of entrance
monument and
landscaping

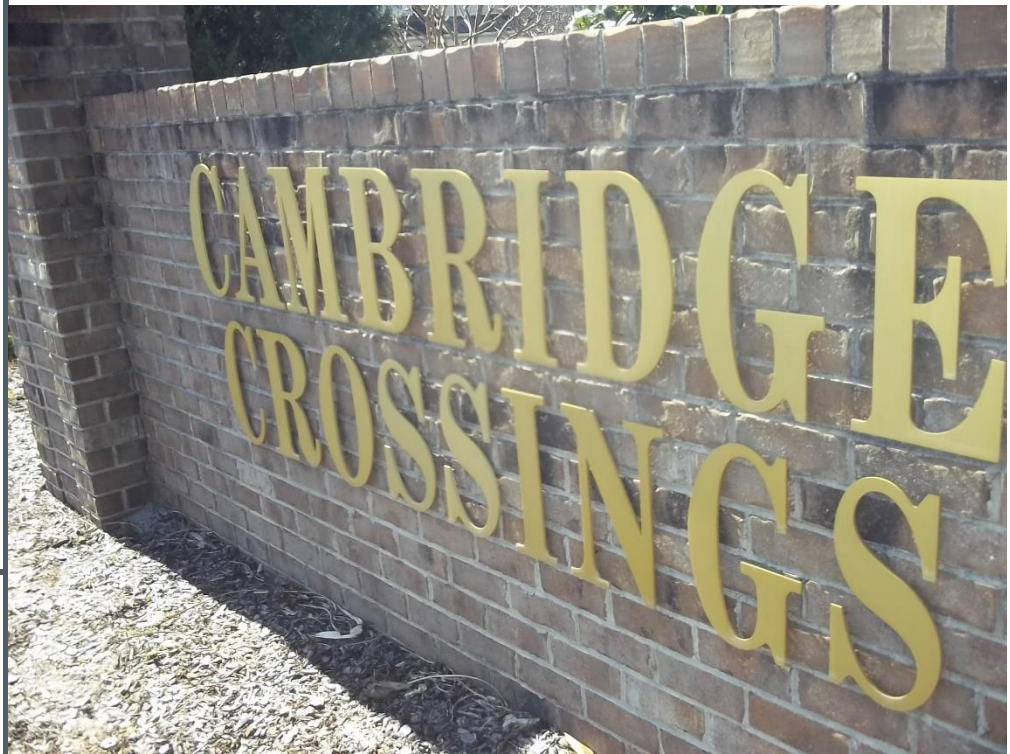
Photo No.
2

View of metal sign
letters at entrance

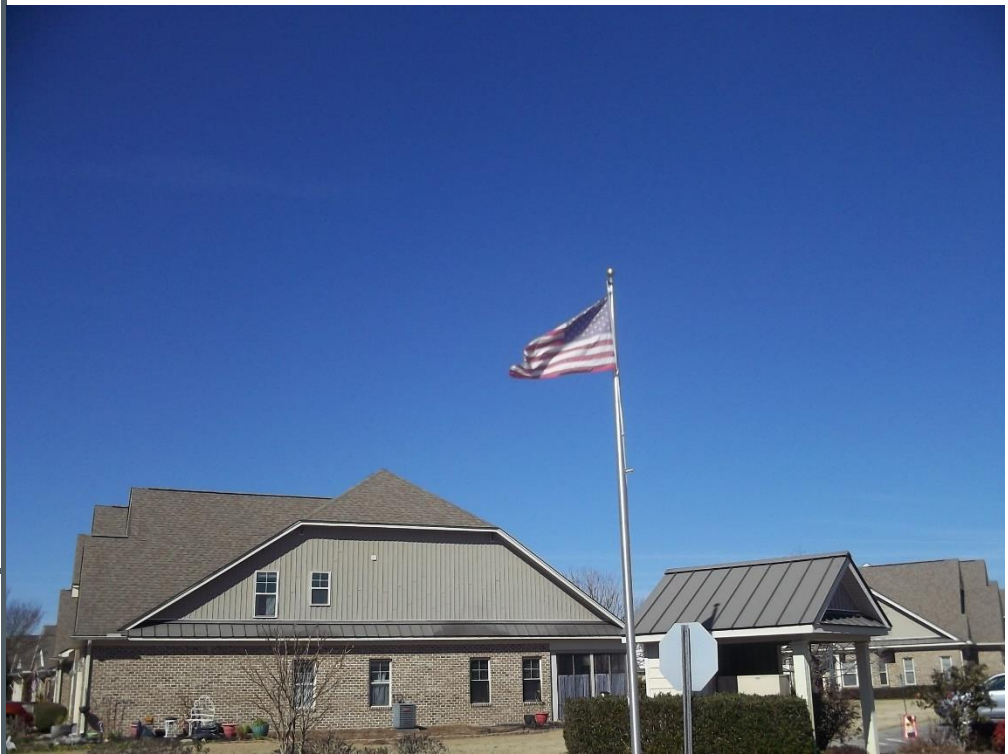
Photo No.
3

View of flagpole, mail center and gable end of typical 2-story building

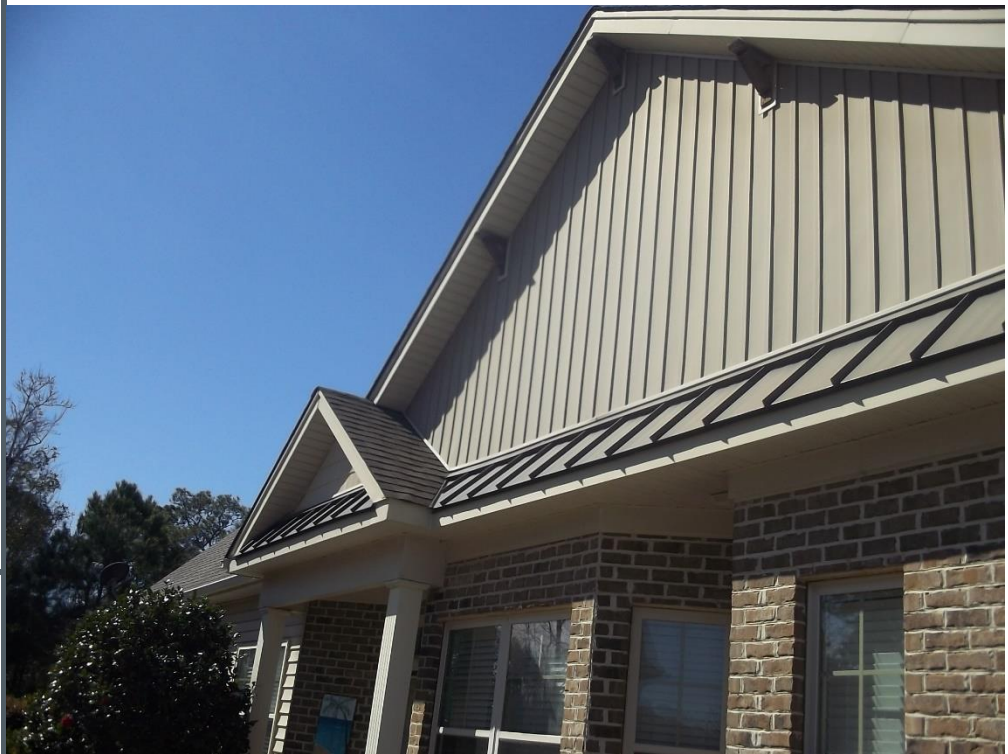
Photo No.
4

The vinyl siding appeared to be in reasonable condition with no major weathering/chalking or loose sections of siding noted. Vinyl siding has an expected life of up to 50-years and full replacement of the siding is not anticipated during the term of this assessment. The brick veneer also appeared to be in relatively good condition; however, the Board advised that significant brick veneer replacement has been required at the front elevation of buildings due to water intrusion between the brick and framing. We observed replaced/repointed sections of brick during our inspection. Based on the Association previous experience with water intrusion into the framing/brick veneer cavities and the likelihood that some vinyl and trim repair/replacement will be required; we have provided an annual allocation in reserves for exterior building repairs.

View of upper elevation vinyl siding and architectural wood feature

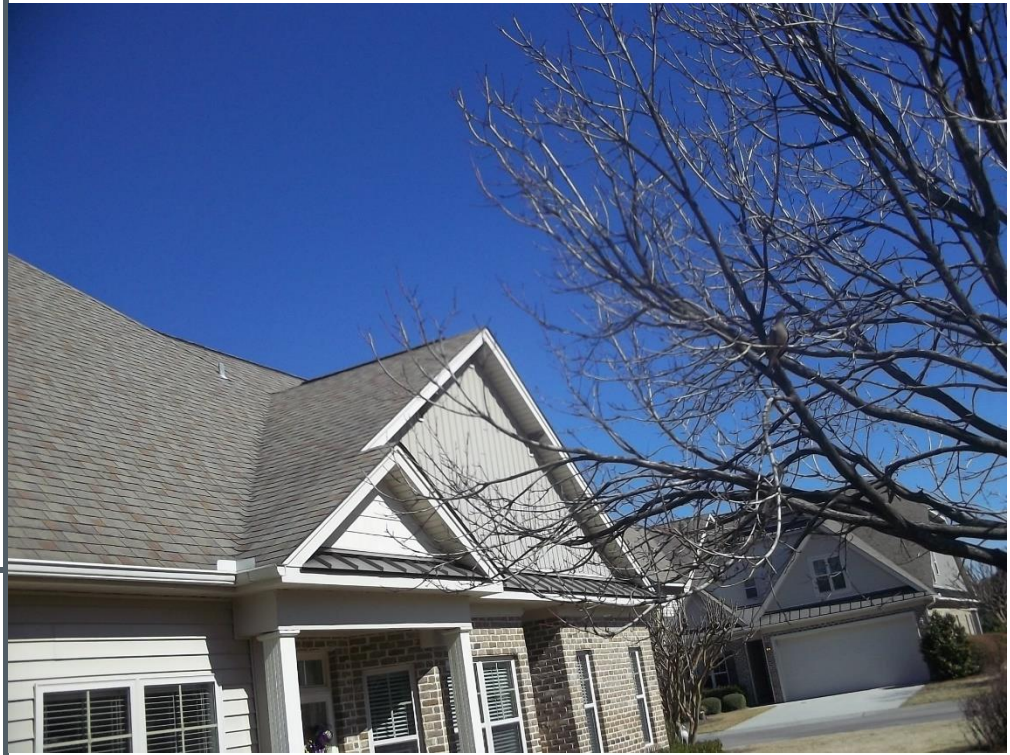
Photo No.
5

The building roofs are clad in architectural grade asphaltic fiberglass shingles and varied in condition. We observed some sections of replacement shingles on two-story and one-story buildings and understand that roof repairs (particularly at valleys) and significant flashing repairs have been periodically required on the older buildings. No complete roofing replacements on any buildings have been completed to date. Architectural grade shingles typically have an expected life of 20-25 years, but based on the history of the roofs we believe full roof replacement will be required within 20 years of installation of roofing.

View of roof shingles and valley over 2-story building

We have allocated funds for eight phases of roof replacement. The 2-story buildings constructed in 2007 and through 2013 are included the first five (5) phases of roof replacement which require roof replacements in consecutive years beginning in 2023 and ending in 2027. Note that these roofs are more complex than the newer roofs and cost per square for shingle replacement is higher. The newer one-story buildings were all constructed between late 2015 through 2017 and funds are allocated in three additional phases (2036, 2038 and 2040) to reroof all these building (6th, 7th and 8th phases of roofing replacement).

A re-roofing sequence should include removal of the existing shingle surfacing, replacement of any inadequate roof sheathing, replacement of any damaged flashing, and replacement of drip edge components. We strongly recommend that any re-roofing project closely follow procedures outlined by the National Roofing Contractors Association's *Roofing and Waterproofing Manual*, Current Edition.

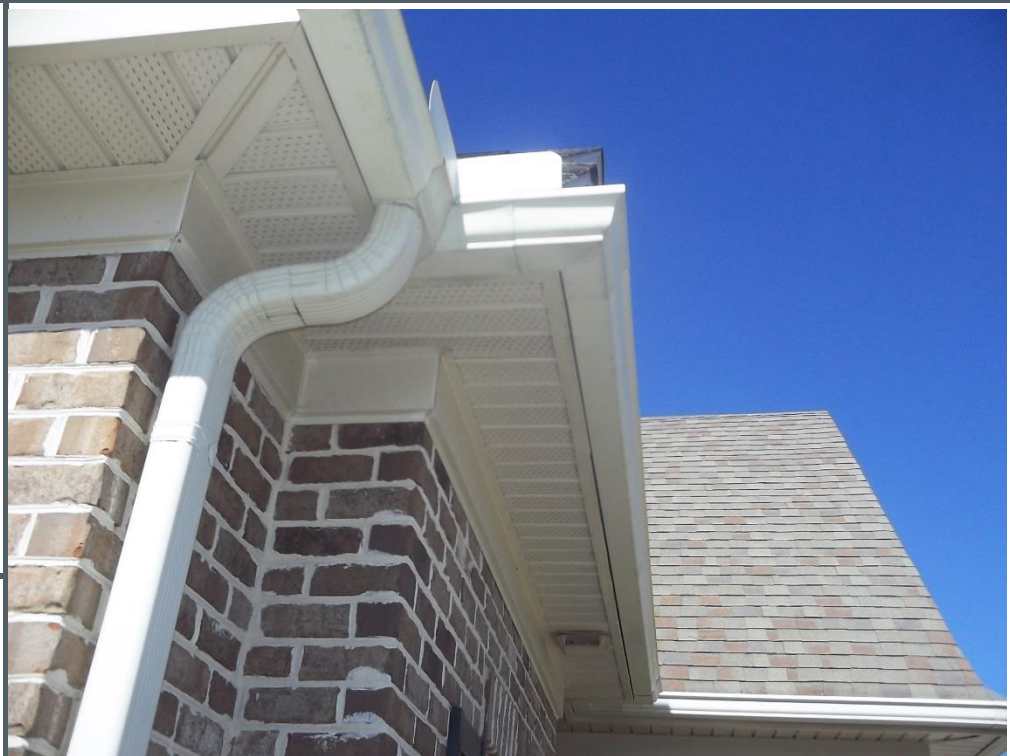
Photo No.
6

Close-up view of vinyl soffit, metal fascia and gutter/downspout

We have also included an allowance for replacing gutters and downspouts as required on the buildings in 2033 (typically bulk of the work will actually be completed during roof replacements). As gutters are replaced, consideration should be given to upgrading the existing gutters to higher capacity 6-inch gutters.

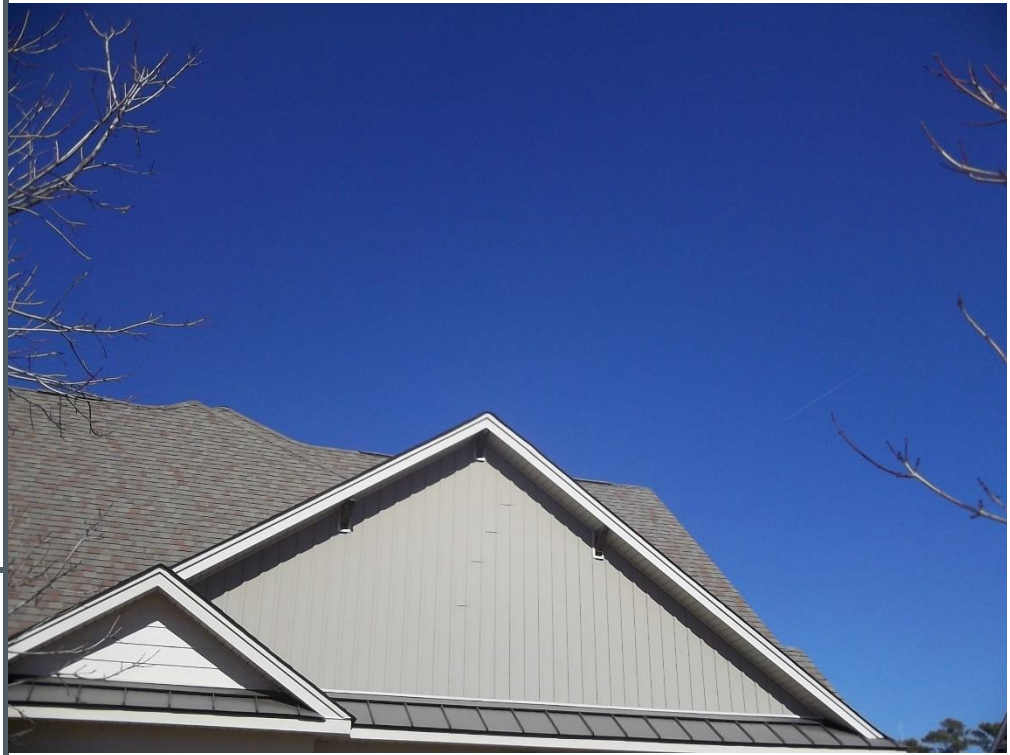
Photo No.
7

Another view of two-story building upper elevation and roof shingles

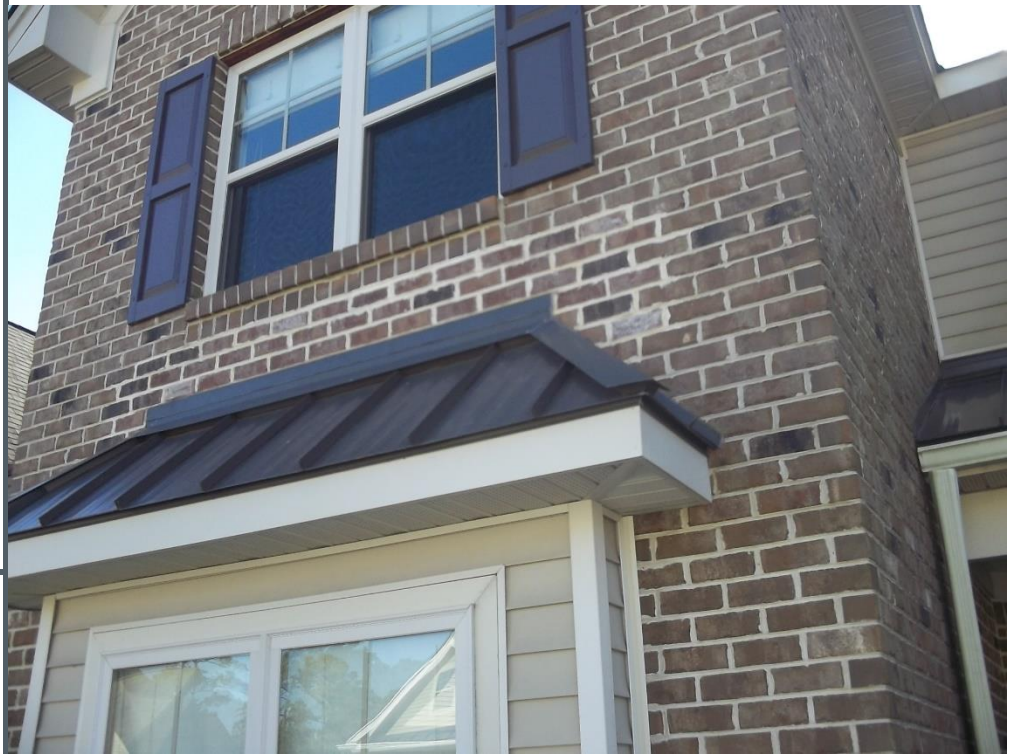
Photo No.
8

View of 2-story building front elevation brick veneer repairs

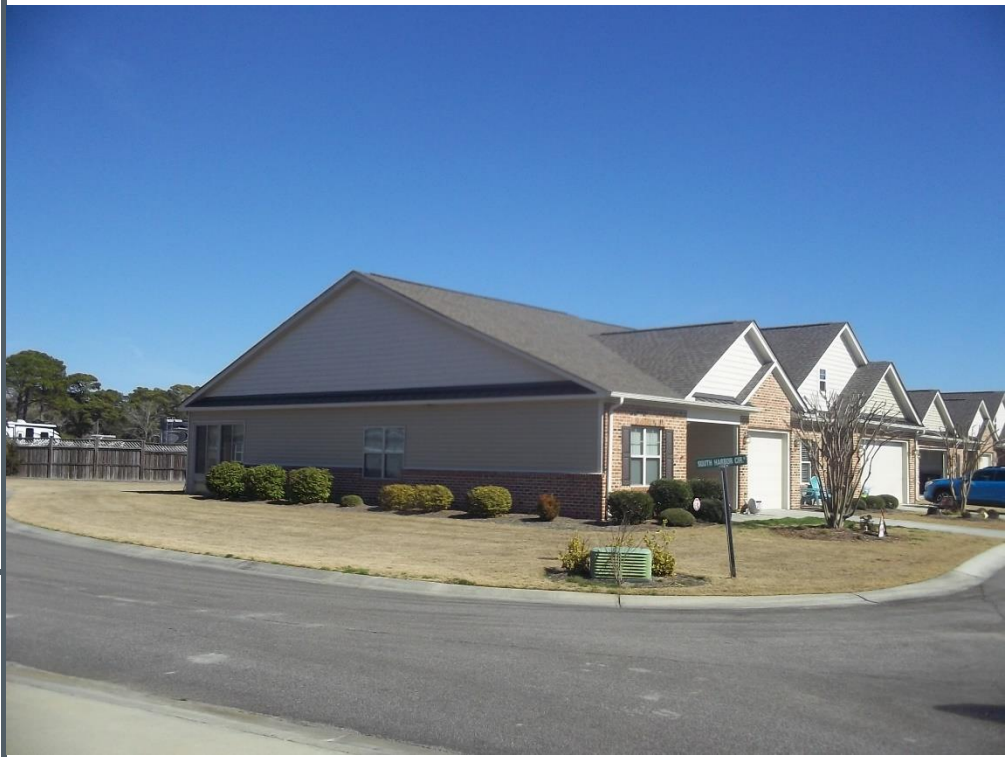
Photo No.
9

View of typical one-story townhome building

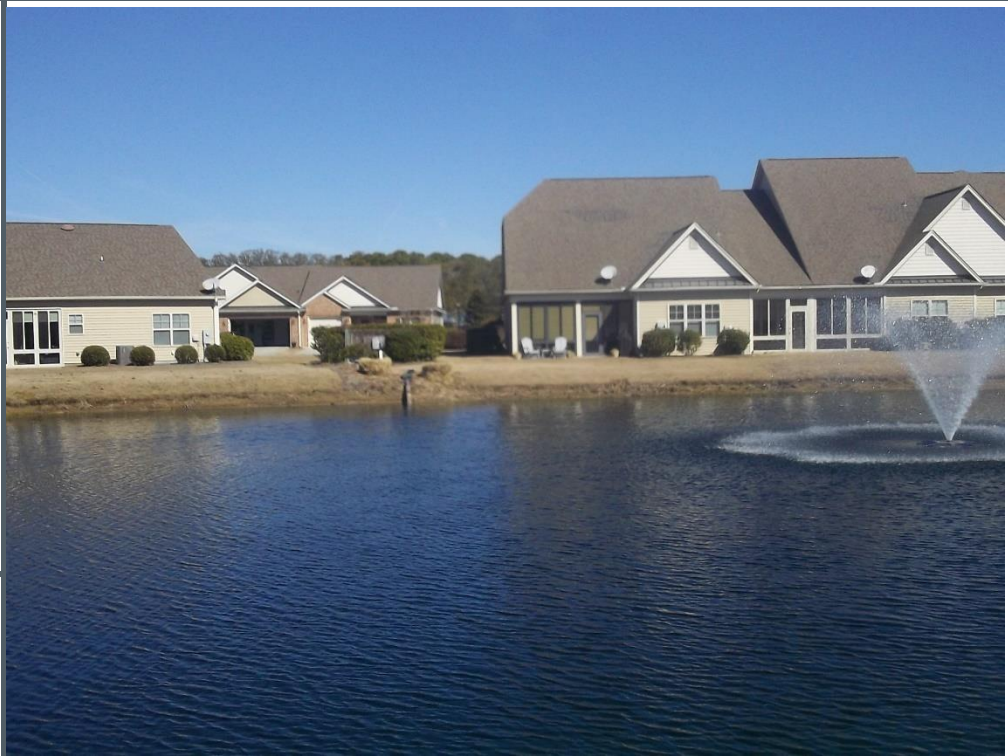
Photo No.
10

The stormwater detention pond includes a center fountain with electrical and controls. We were advised that fountain components were replaced in approximately 2018/2019 and we have allocated funds to replace the fountain and auxiliary components in 2028 and on a 10-year cycle.

View of one-story buildings and pond fountain

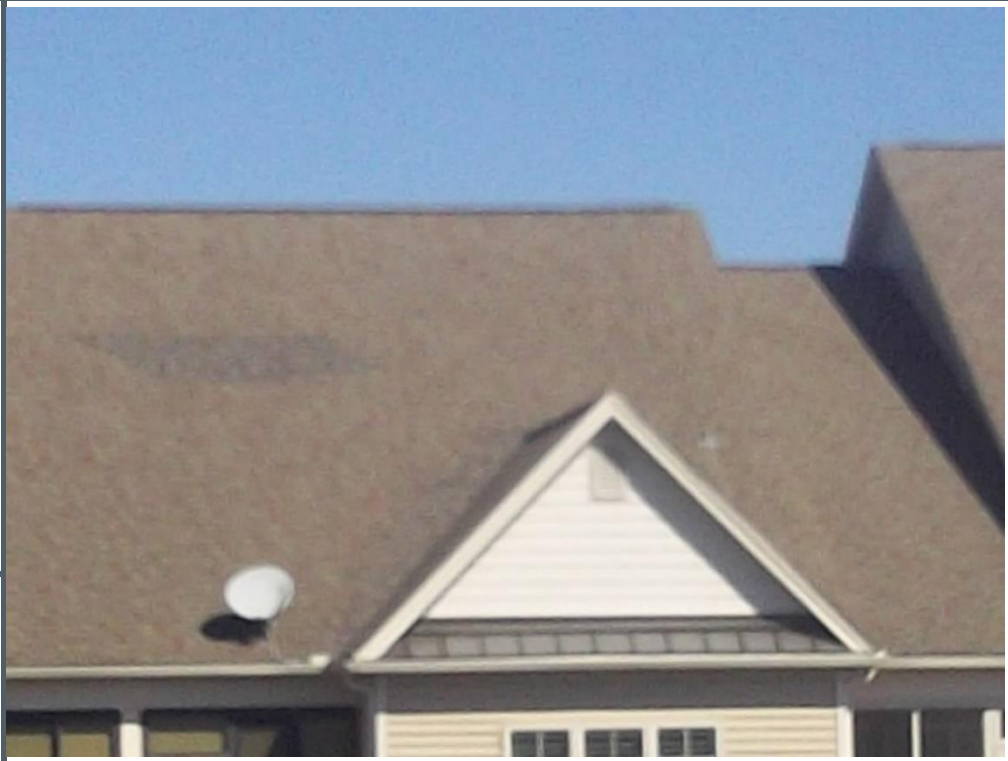
Photo No.
11

Description
View of replaced section
of shingles on one-story
building

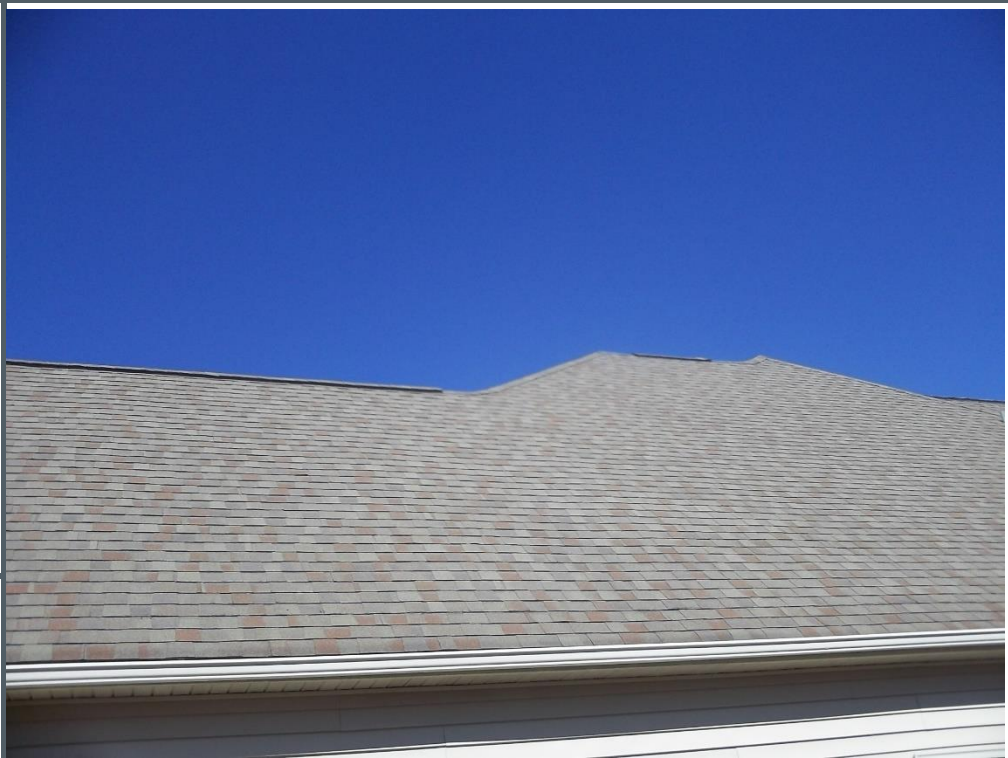
Photo No.
12

Description
Another view of typical
architectural grade
shingles on one-story
building roof

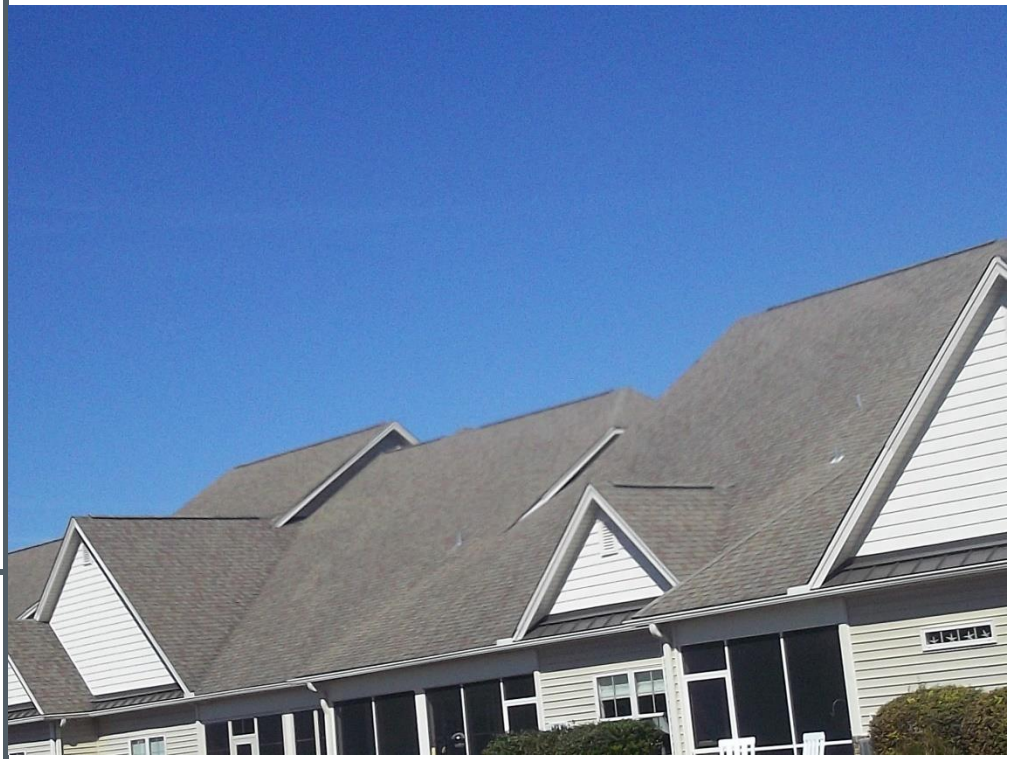
Photo No.
13

View of more roofing shingles and rear screened porches

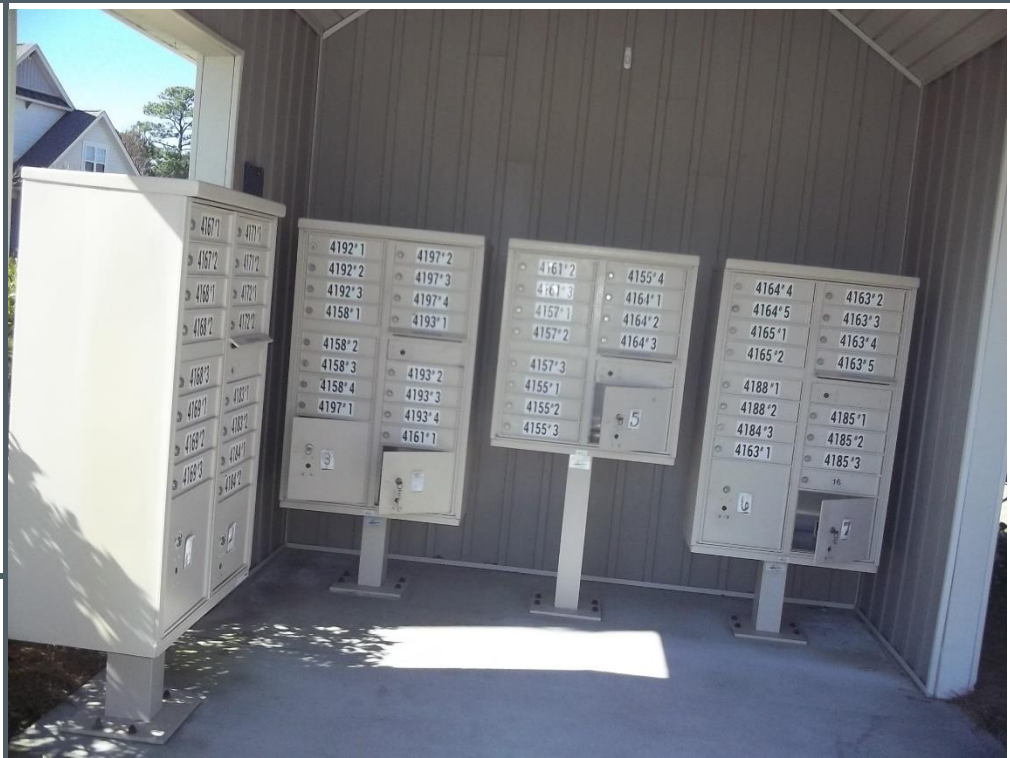
Photo No.
14

Typical mail kiosks

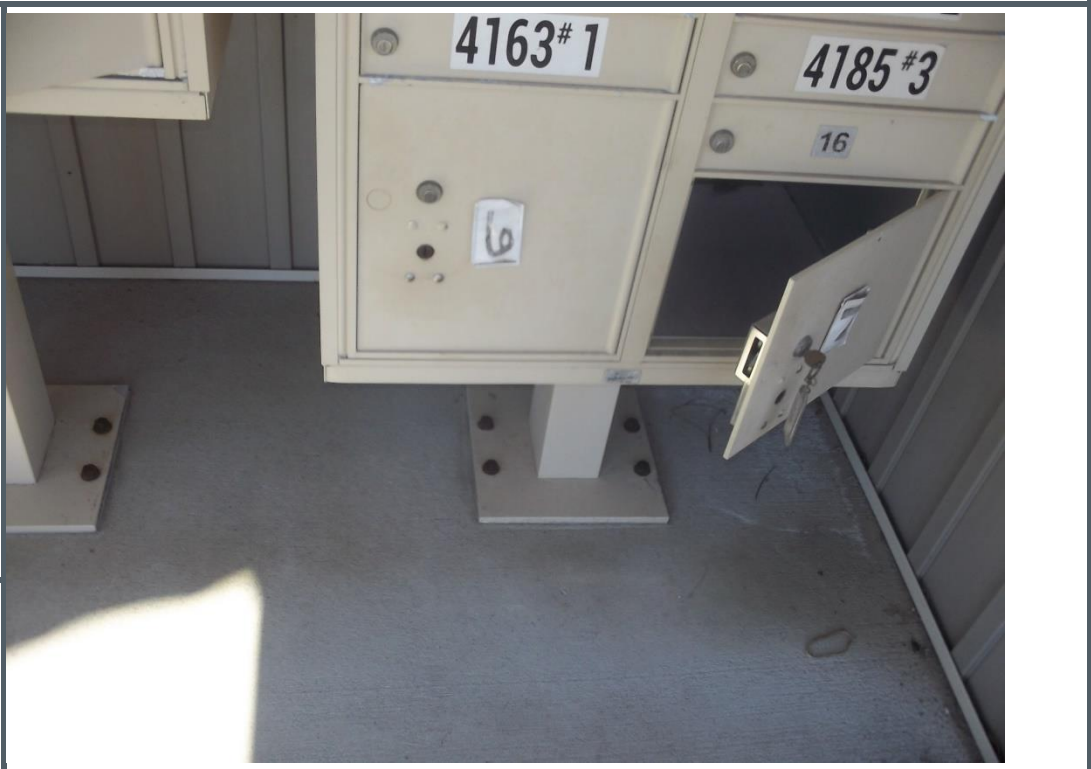
Photo No.
15

Two wood framed mail centers with roofs and siding are centrally located in the community. The mail centers include mail kiosks (6 total) that generally appeared to be in good condition with some rusted base anchors observed. Repair/replacement of rusted anchors is considered a Maintenance expense. We have allocated funds to replace all mail box kiosks near the end of the term of this analysis (2042). Additionally, major repairs/rebuild of the 2 vinyl-sided and shingled roof mail centers are anticipated by 2042.

Description
Note rusted anchor bolts
at base of kiosks

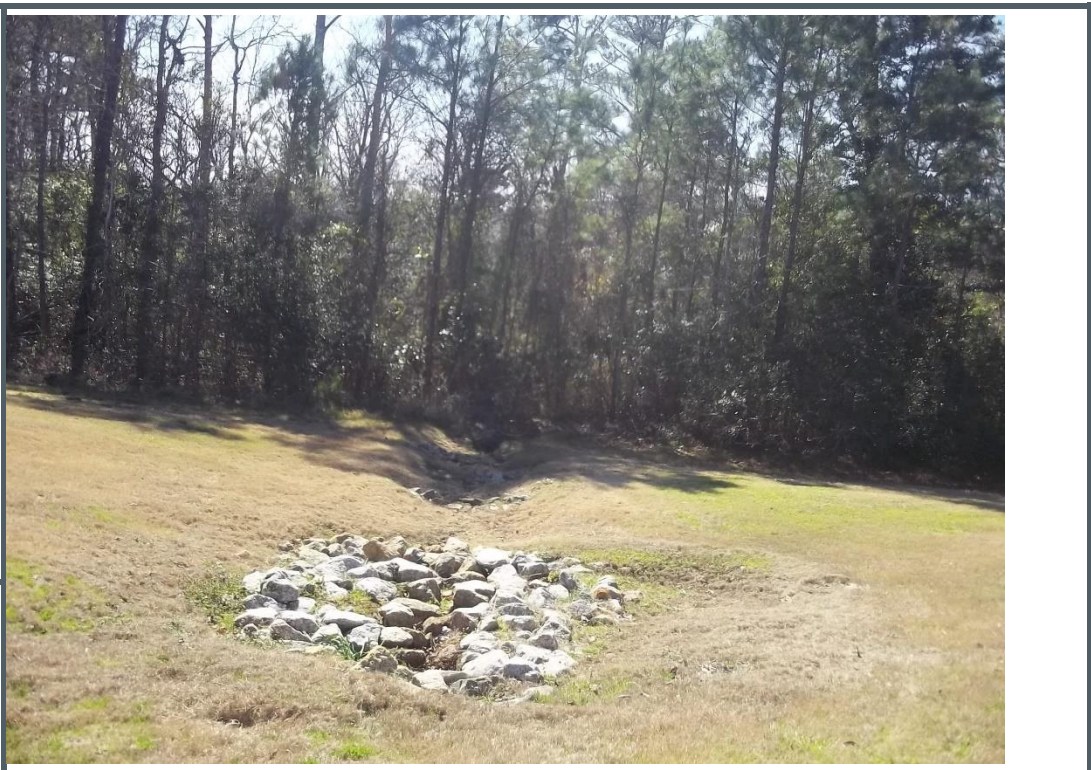
Photo No.
16

We also observed minor erosion and granite rip rap displacement developing in common areas around the community. We have allocated funds for drainage system improvements on a 7-year cycle beginning in 2026. Drainage system improvements would likely include re-trenching swales, installing additional stone rip rap armoring and other erosion control measures, and possibly installing additional drainage systems.

Description
Rip rap swale/dam
behind Buildings
4197/4193

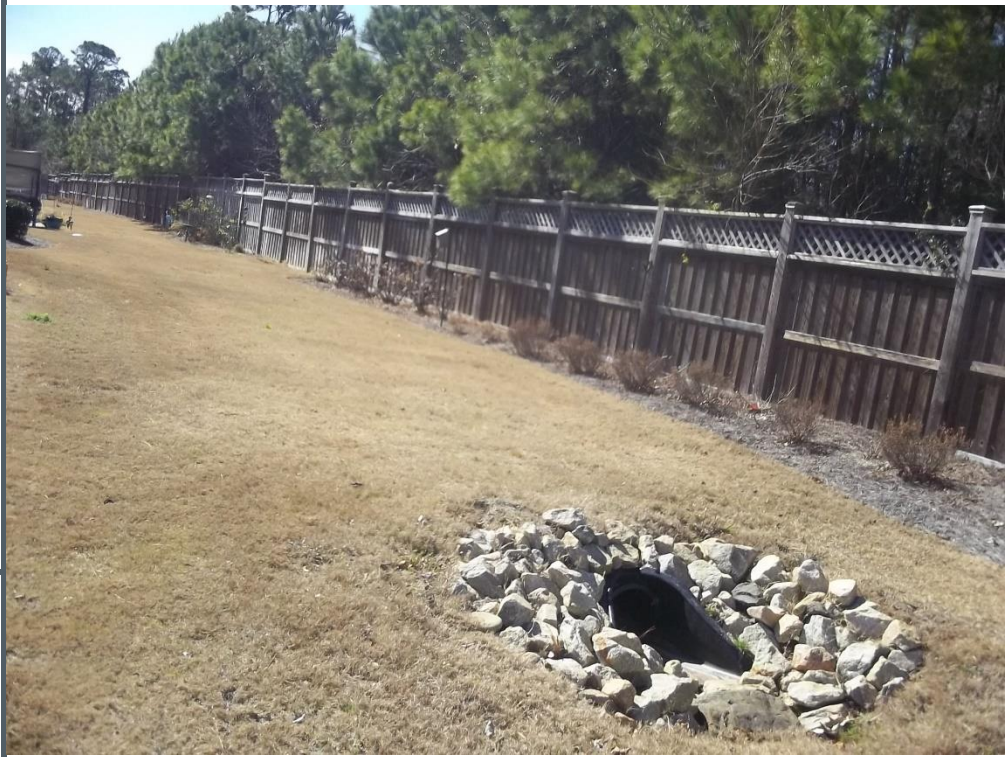
Photo No.
17

Rip rap and discharge of stormwater piping at northwest end of site

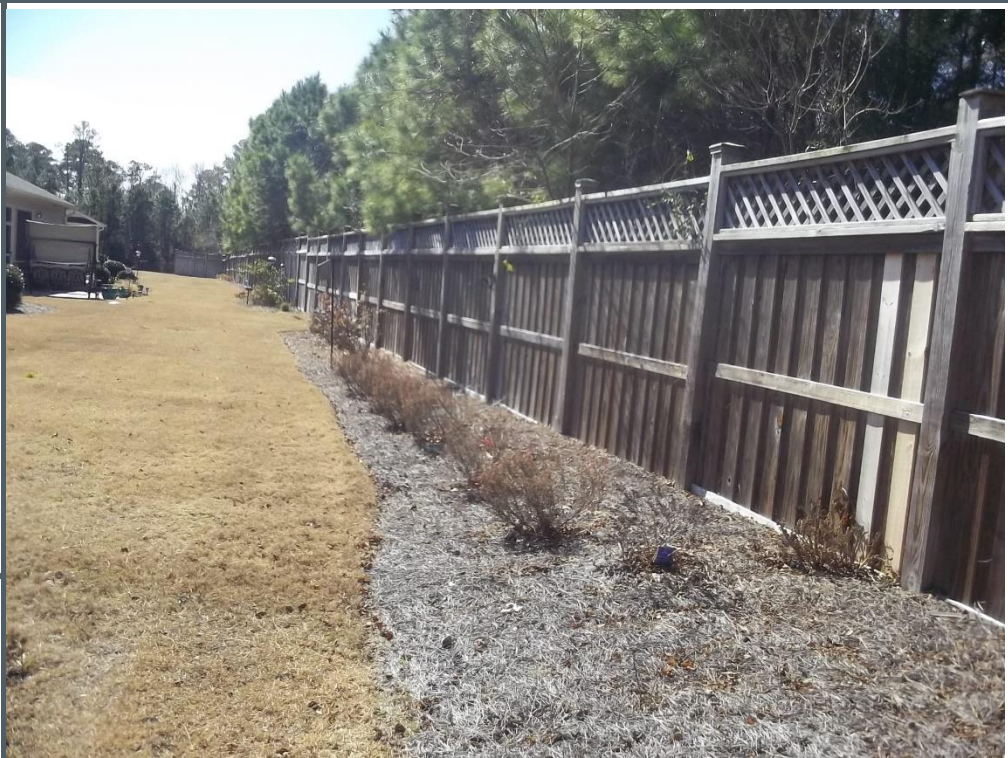
Photo No.
18

Long sections of wood privacy fencing are located behind all the buildings constructed at the perimeter of the property with the exception of Building Nos. 4185, 4187, 4193 and 4197. We observed sections of the repaired/replaced and individual replacement wood slats. We have allocated funds to replace all the wood privacy fencing beginning in 2028. This wood fencing has an expected useful life of approximately 20 years and we anticipate most original fencing will be significantly deteriorated/discolored in the next 5-8 years. Note that the community may continue to only replace sections of fencing as required, but we believe all fencing will be replaced during the term of this analysis.

View of wood privacy fencing condition and replacement slats

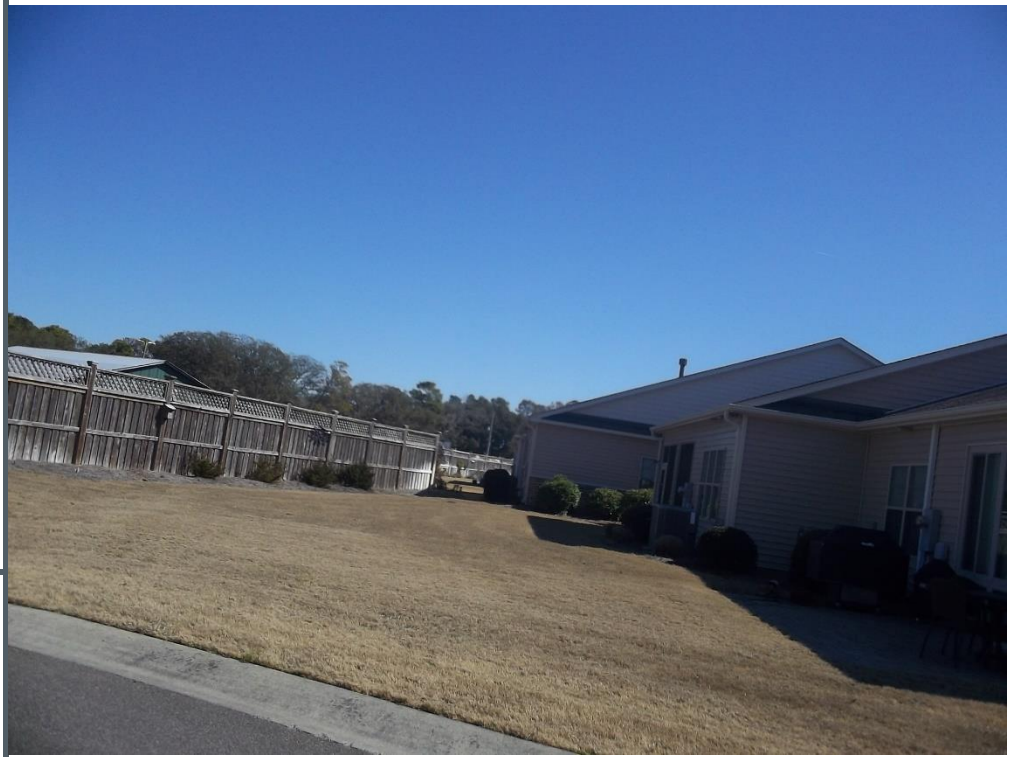
Photo No.
19

Another view of wood fencing behind one-story buildings

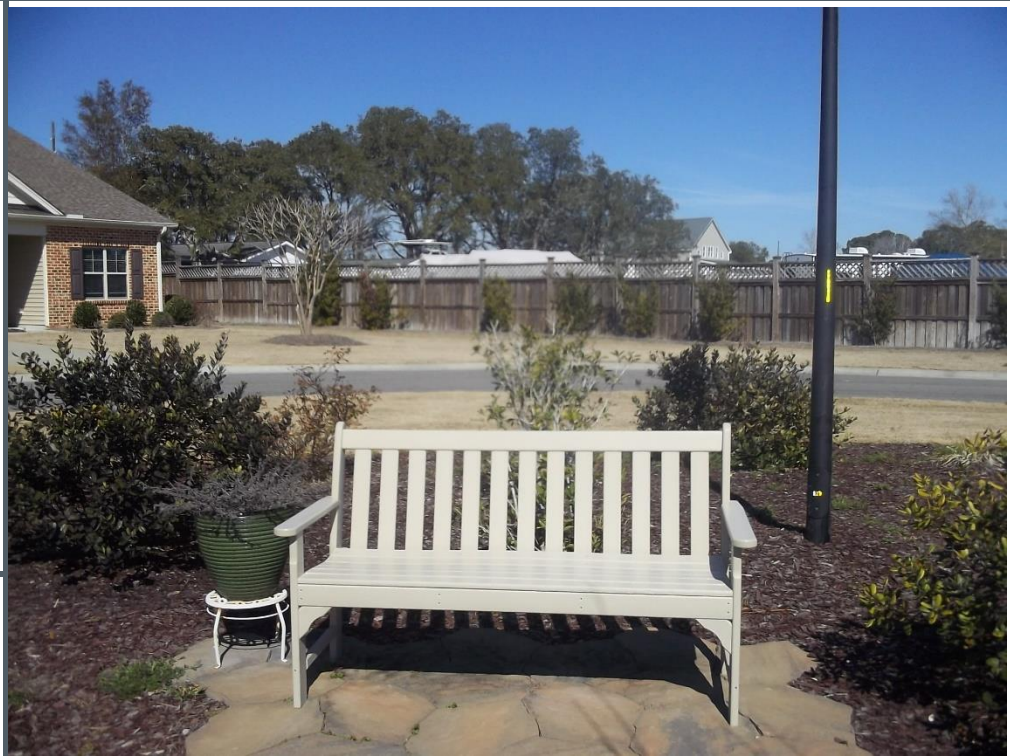
Photo No.
20

Sitting area and bench north end of site

No significant amenities are provided for this community. Replacement of the small composite bench in the landscaped island at the north end of the community and replacement/repairs to flagpole and pole up-lighting near the entrance should be funded from the Maintenance account.

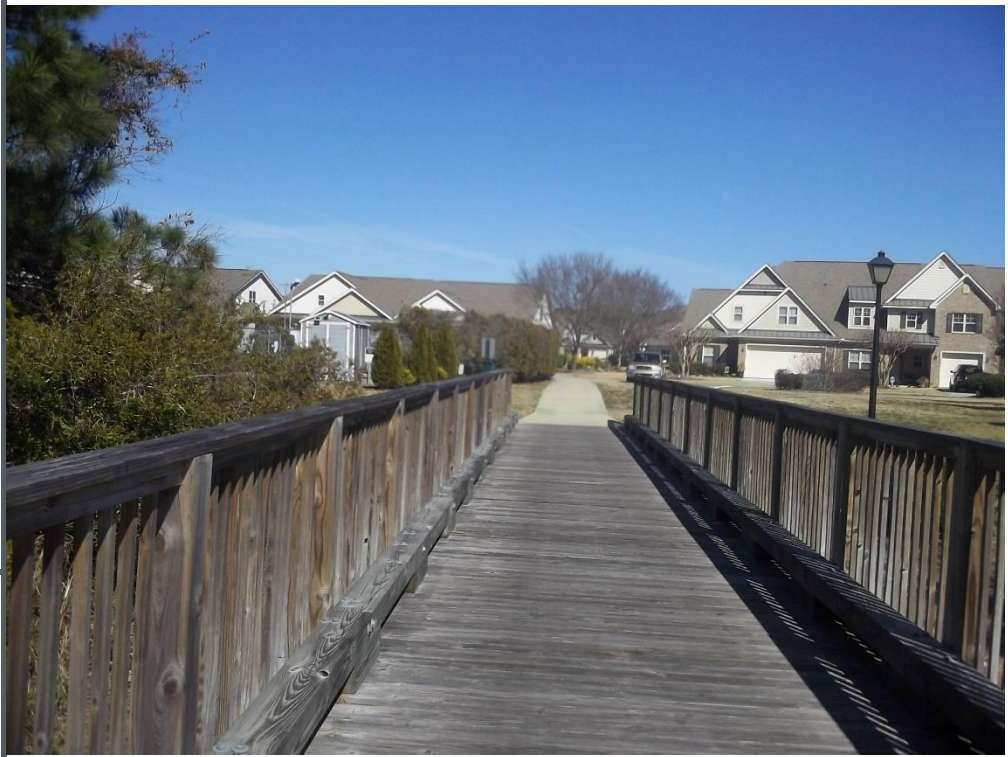
Photo No.
21

View of elevated wood walkway/golf cart bridge on subject property

wood framed structural components (girders/posts/bracing) appeared to be in relatively good condition and complete rebuild of the elevated walkway is not anticipated during the term of this analysis. However, after 20-years of life, replacement of the wood decking and railing system will likely be required. We have allocated funds to replace all the wood decking and railings and complete minor structural repairs as required in 2036.

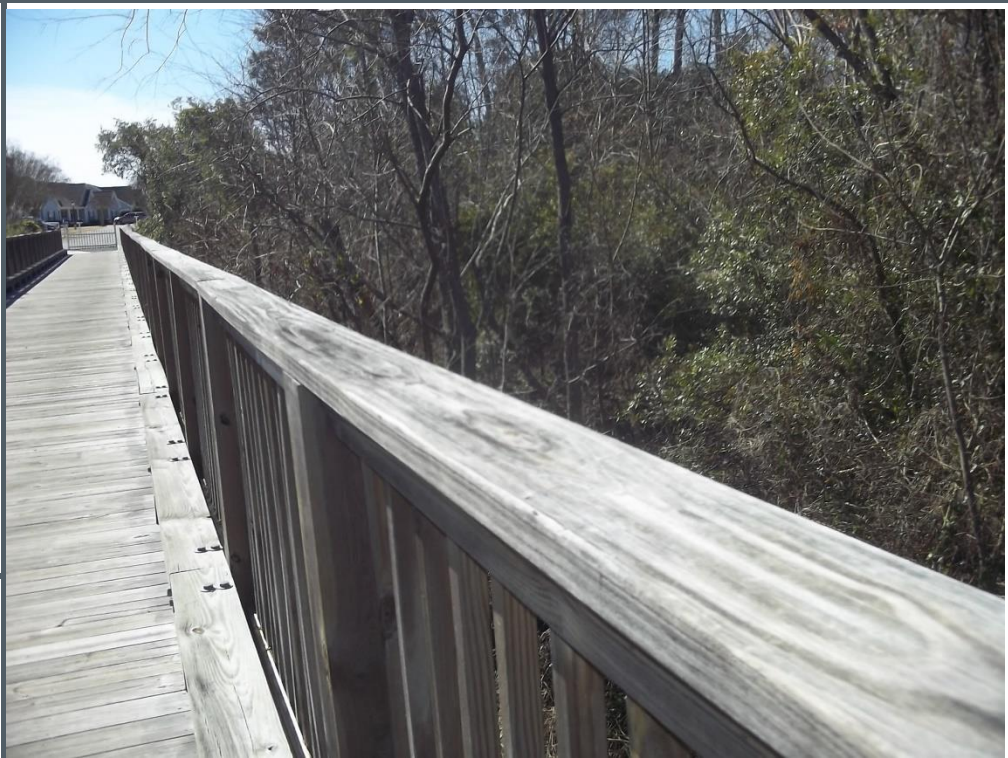
Photo No.
22

Another view of elevated wood walkway and railing

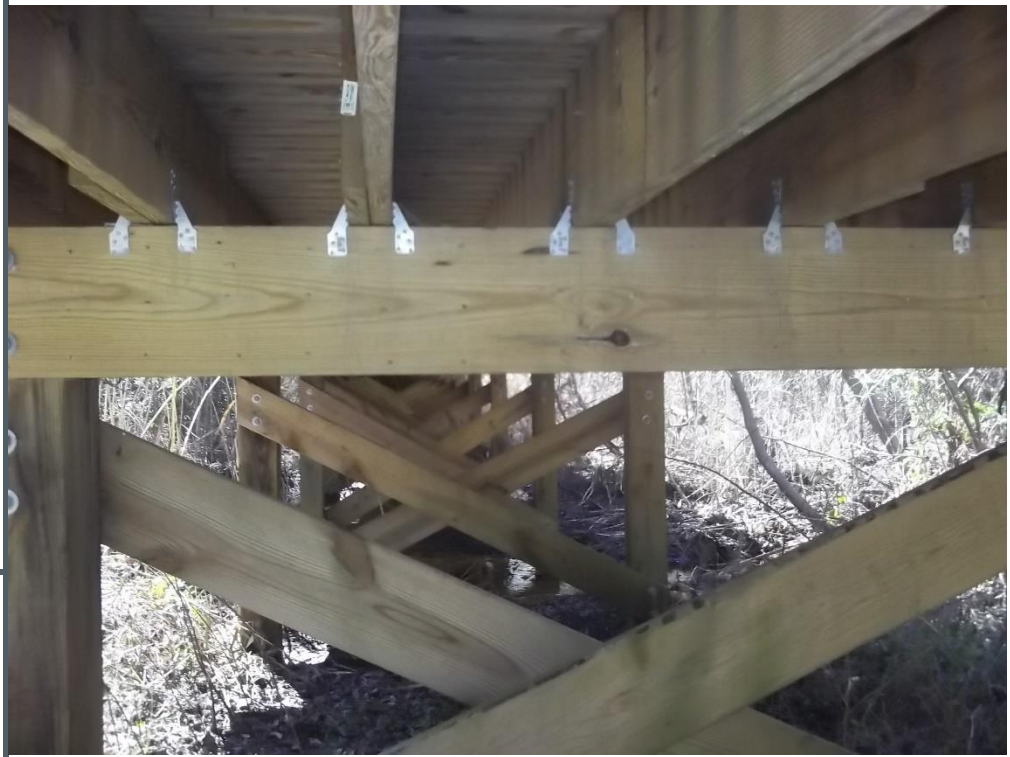
Photo No.
23

View of structural wood girders/ posts and bracing under elevated system

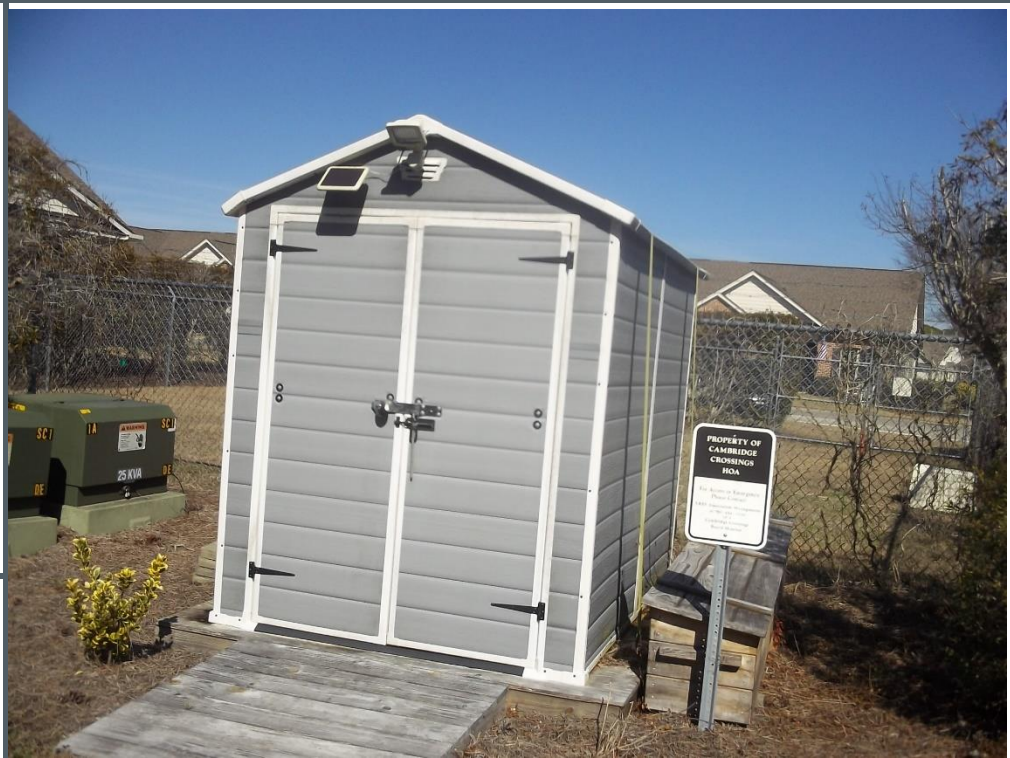
Photo No.
24

Small HOA storage building

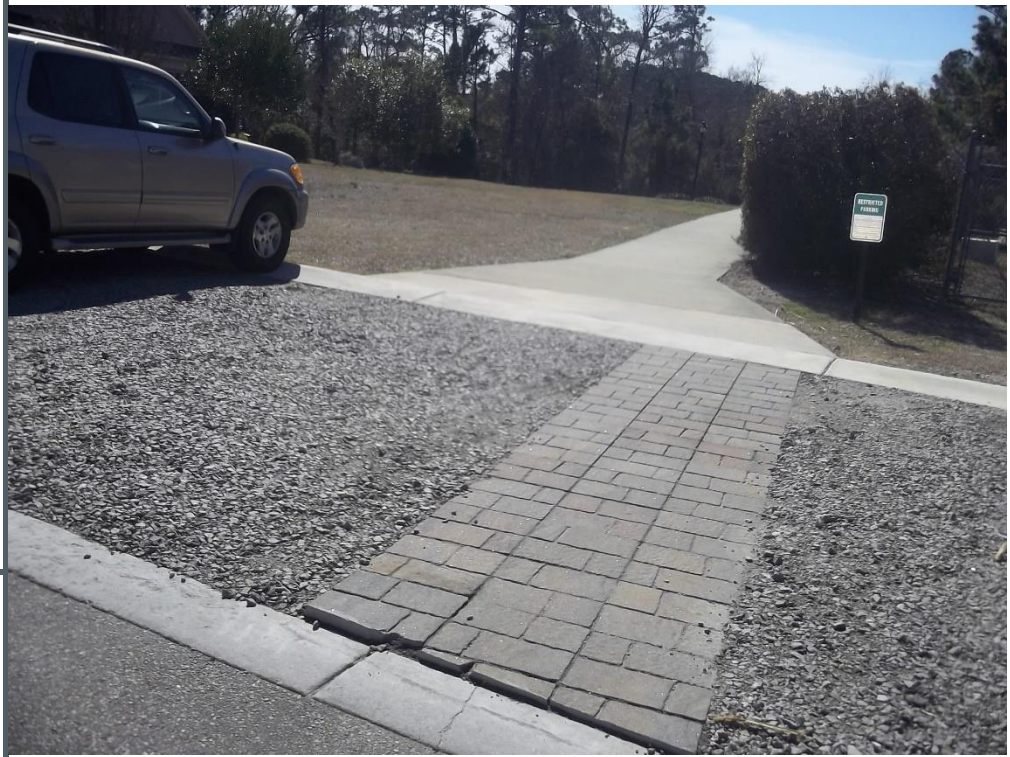
Photo No.
25

Graveled parking area and pavers leading to concrete and elevated wood walkway at southwest end of site

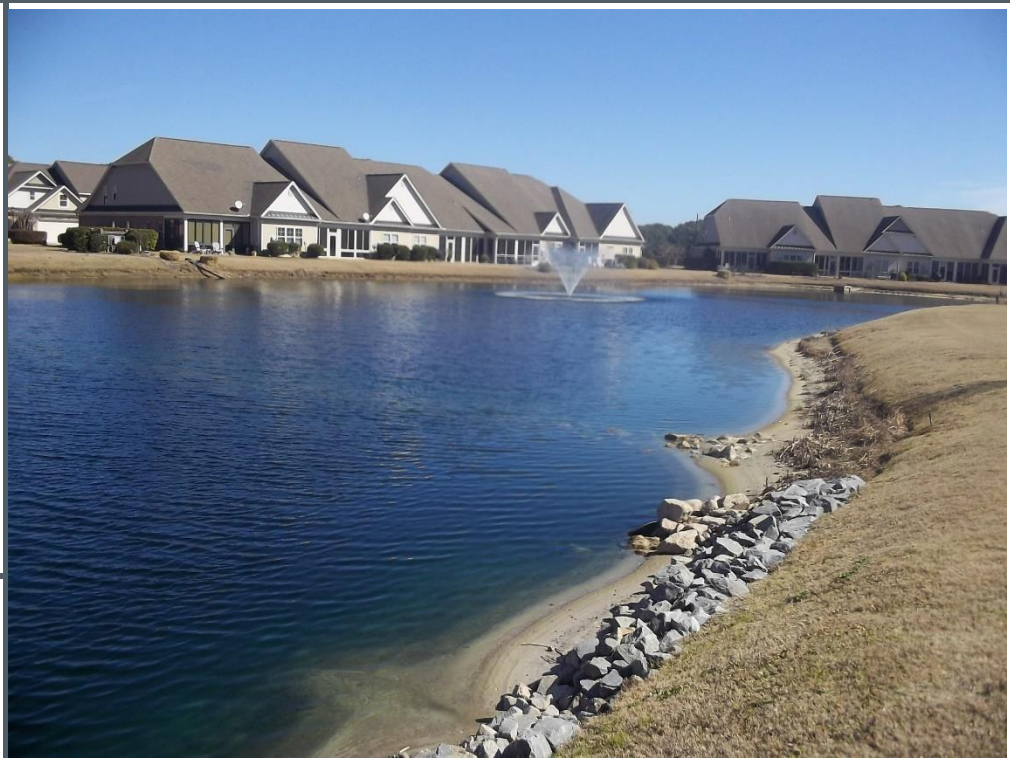
Photo No.
26

A large retention pond has been constructed inside the perimeter of the private street and this pond includes a fountain, forebay, detention and infiltration area. The system appeared to be functioning as intended; however, in order for the stormwater retention system to continue functioning properly, the pond will require regular cleaning and maintenance. We have assumed these maintenance costs including nuisance control, debris and litter removal, inlet and outlet maintenance and inspections (which have been performed) are to be paid from the Operating budget.

View of stormwater retention pond and typical rip rap at embankment

The Association should ensure that the storm water management devices conform to all applicable regulations at all times and this activity is currently underway. In addition to regular yearly maintenance, we anticipate that more significant pond repair work and/or limited forebay or detention and infiltration area dredging will be required periodically. We have allocated funds for very limited dredging, outlet structure/piping repair, pond erosion repairs/replacing riprap reinforcement and/or major shelf repairs in 2031. Because construction around the pond is complete the likelihood of significant sediment deposits into the pond system is minimized.

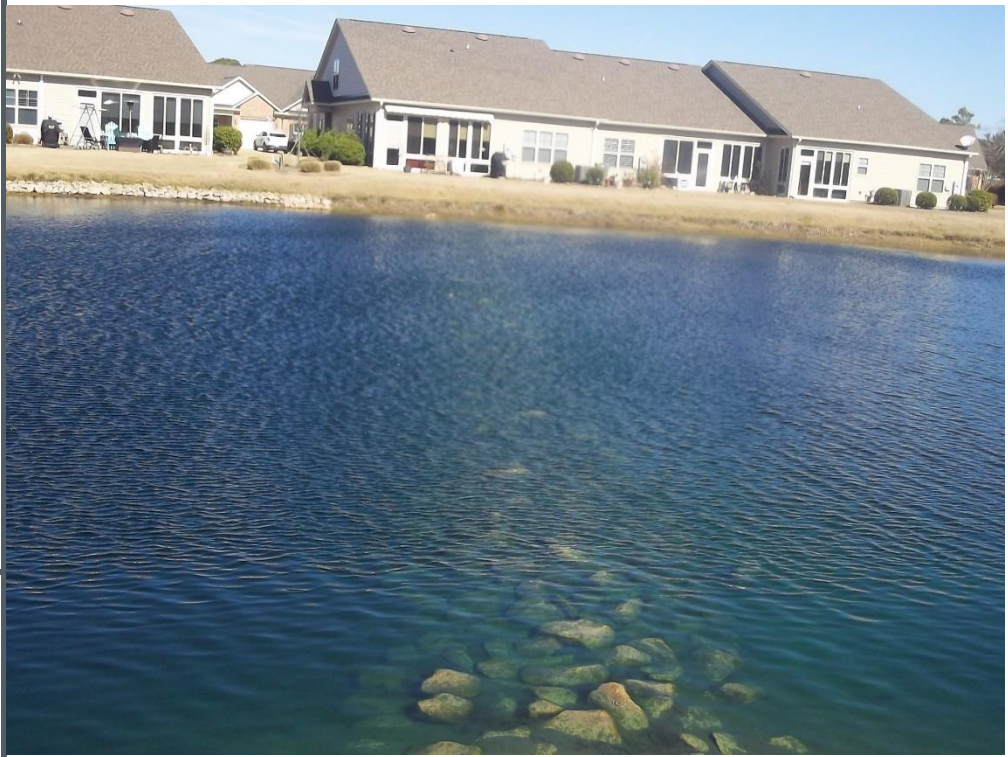
Photo No.
27

View of rip rap which likely defines edge of pond forebay
