**CAMBRIDGE CROSSINGS
HOMEOWNERS ASSOCIATION
SOUTHPORT, NC.**

May 25, 2022

FULL RESERVE STUDY

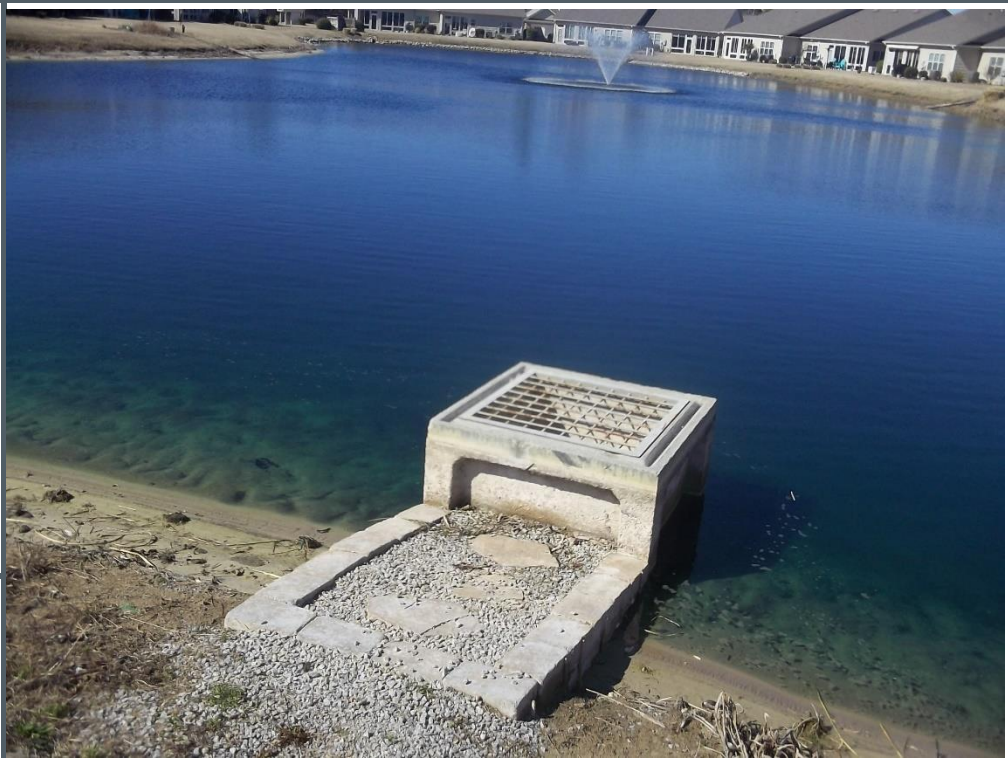
Photo No.
28

Pond outlet/riser structure

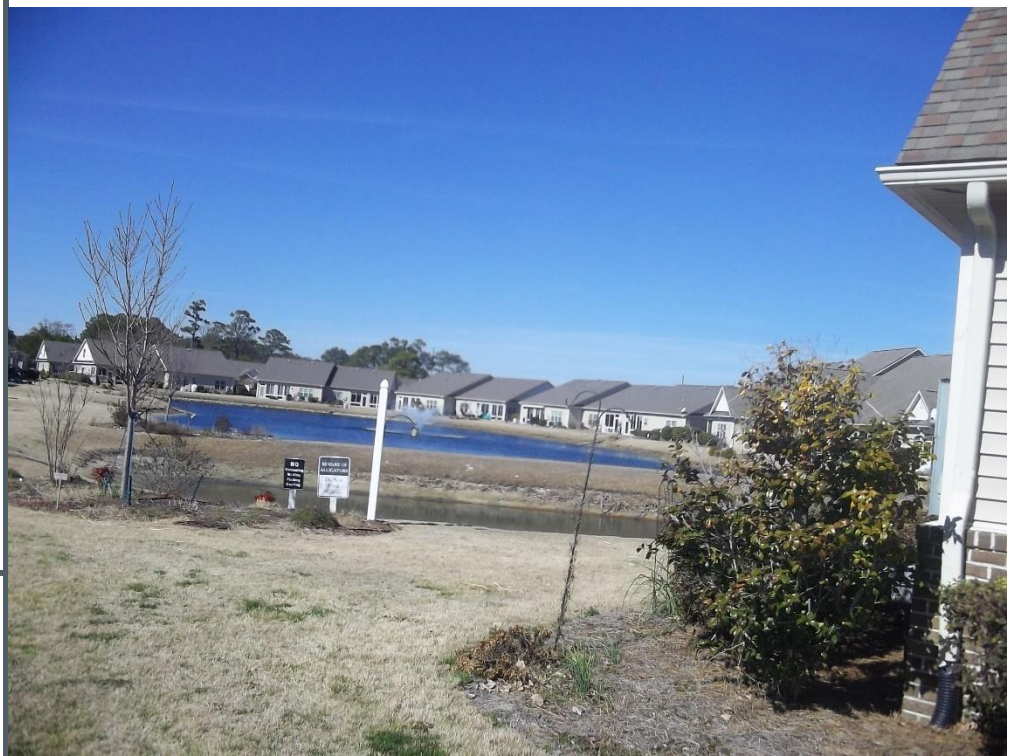
Photo No.
29

View of detention infiltration in foreground and stormwater pond in background

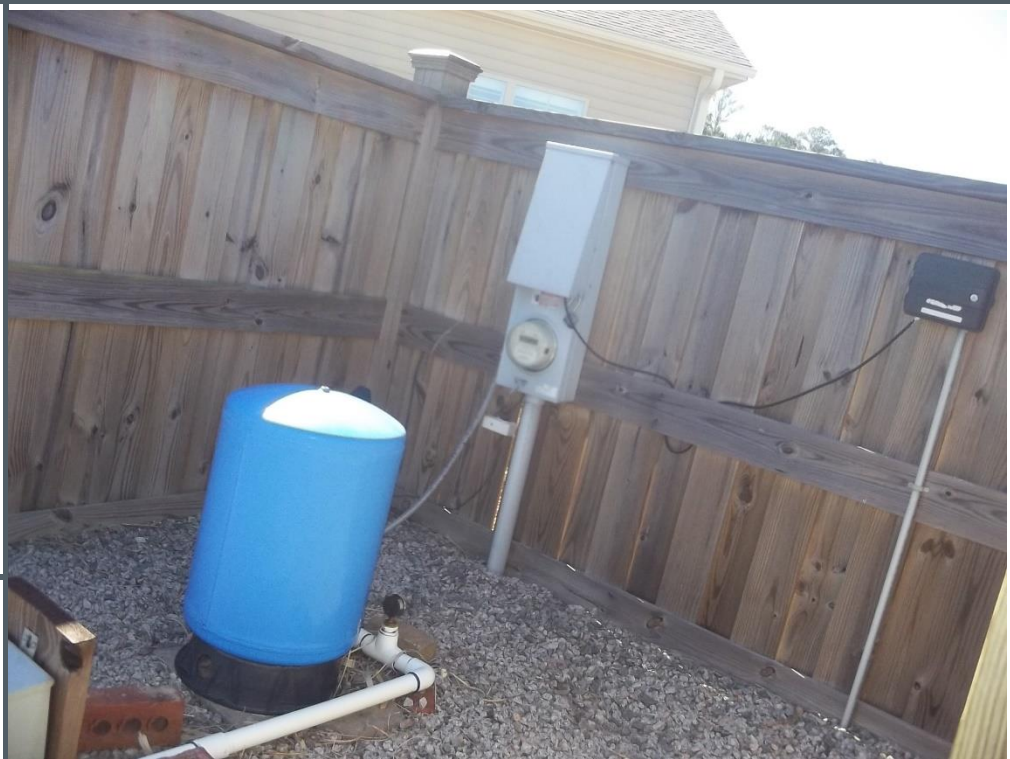
Photo No.
30

One irrigation well with three pumps (two pumps for irrigation and one pump to maintain pond level as required) are located near the stormwater detention pond and we understand one pump was replaced in approximately 2018. These small pumps have an expected life of 10-15 years and funds are allocated to replace one pump every 8 years beginning in 2025.

Wood enclosure and location of irrigation well/tank

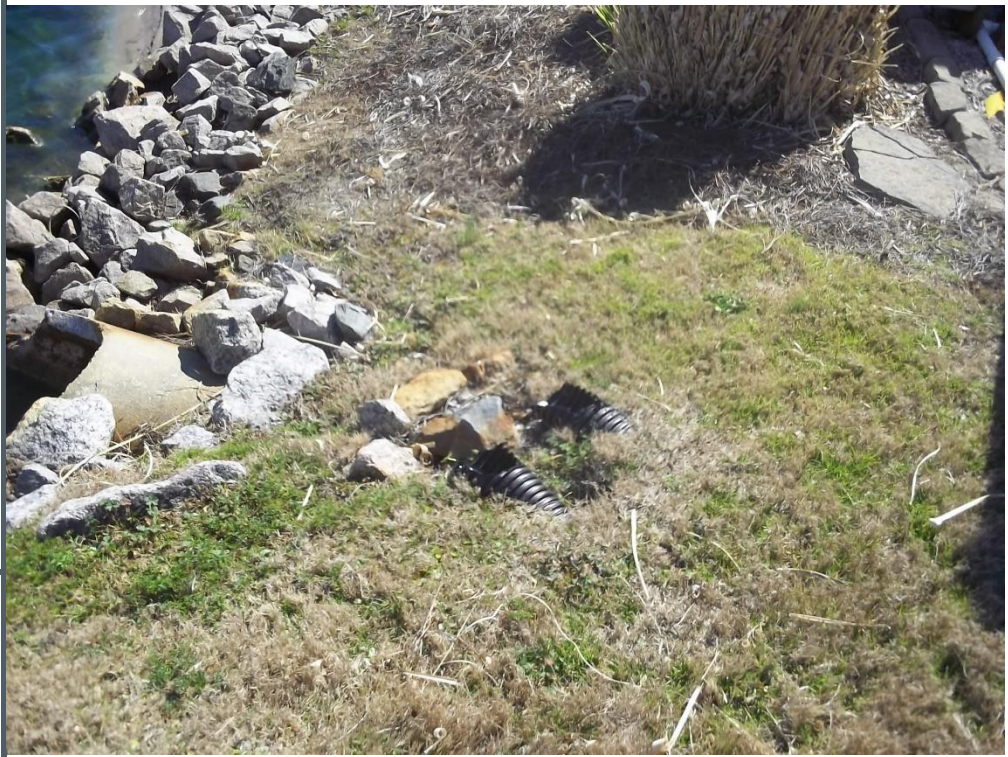
Photo No.
31

View of buried plastic piping discharge at edge of pond and concrete pipe stormwater discharge to pond

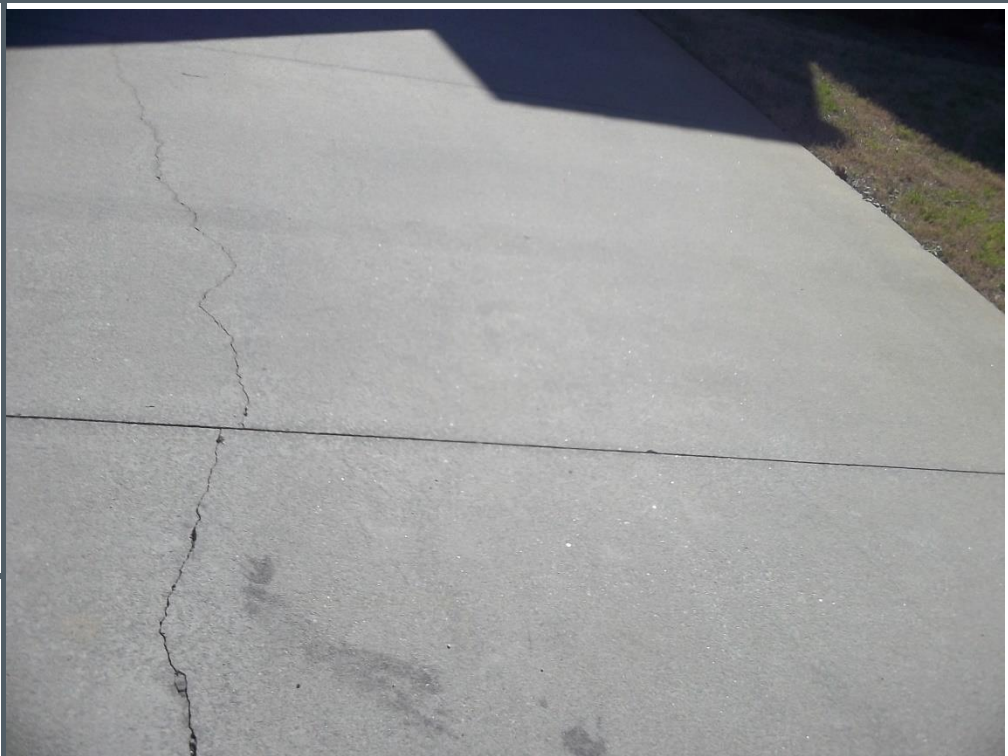
Photo No.
32

Concrete flatwork in the community is comprised of concrete driveways and sidewalks leading to building unit entrances. The Association is responsible for maintenance of these concrete surfaces, but not the concrete patios at the rear of units. Additionally, the Association is responsible for common area sidewalks including the walkway leading to the elevated wood bridge. The concrete flatwork generally appeared to be in good condition with limited areas of minor cracking observed and at least one driveway that previously required sectional replacement. Repairs/replacement of concrete flatwork is considered a Maintenance expense.

Typical cracks in concrete driveway

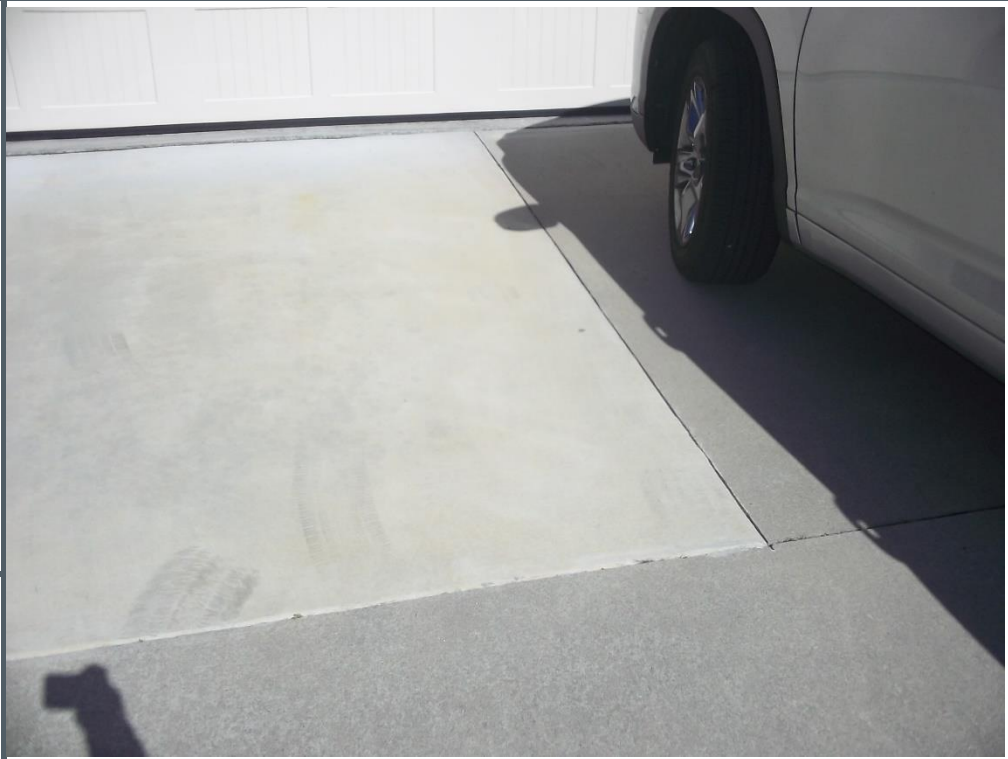
Photo No.
33

Description
Replaced section of
concrete in driveway

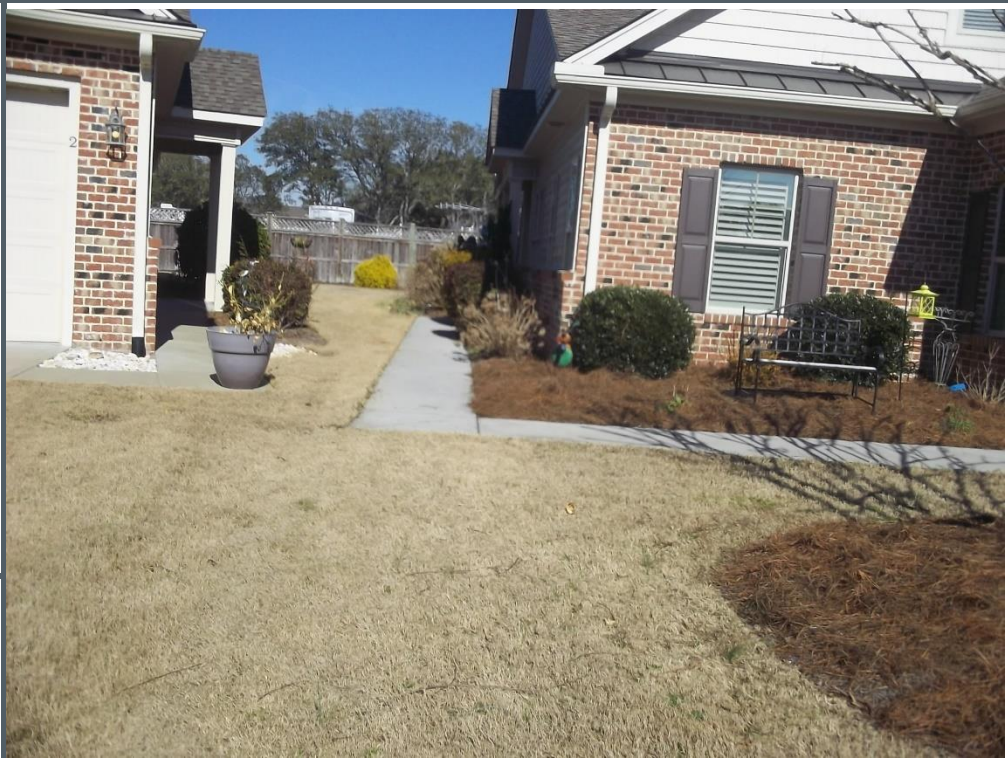
Photo No.
34

Description
Typical concrete
walkway in front and
side of unit

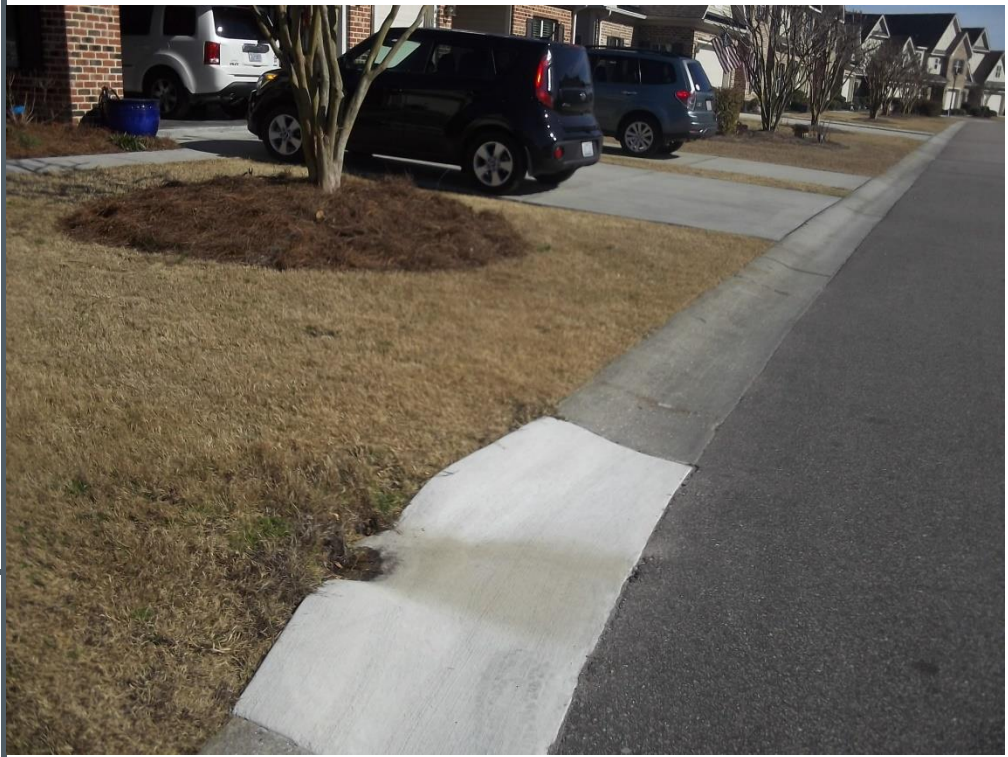
Photo No.
35

View of replaced section of valley gutter

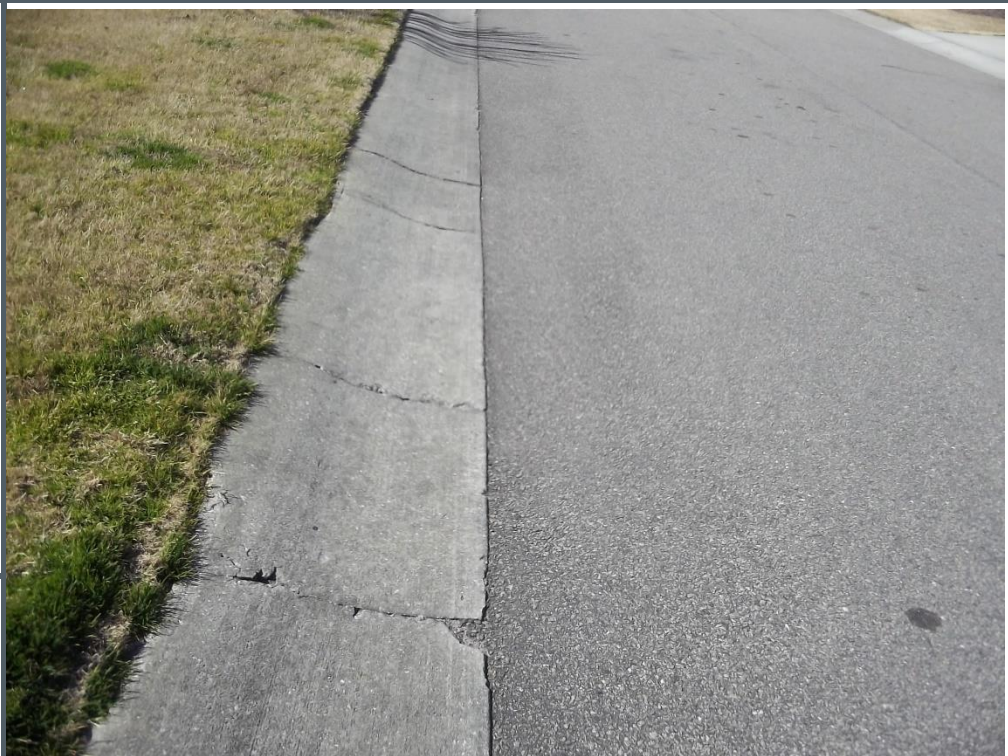
Photo No.
36

Concrete valley gutter is predominately installed along the both sides of the private streets. We observed some cracking in sections of gutter and one section of replacement curb/gutter observed. Repairs/replacement of gutter is considered a Maintenance expense.

Typical cracks in concrete valley gutter

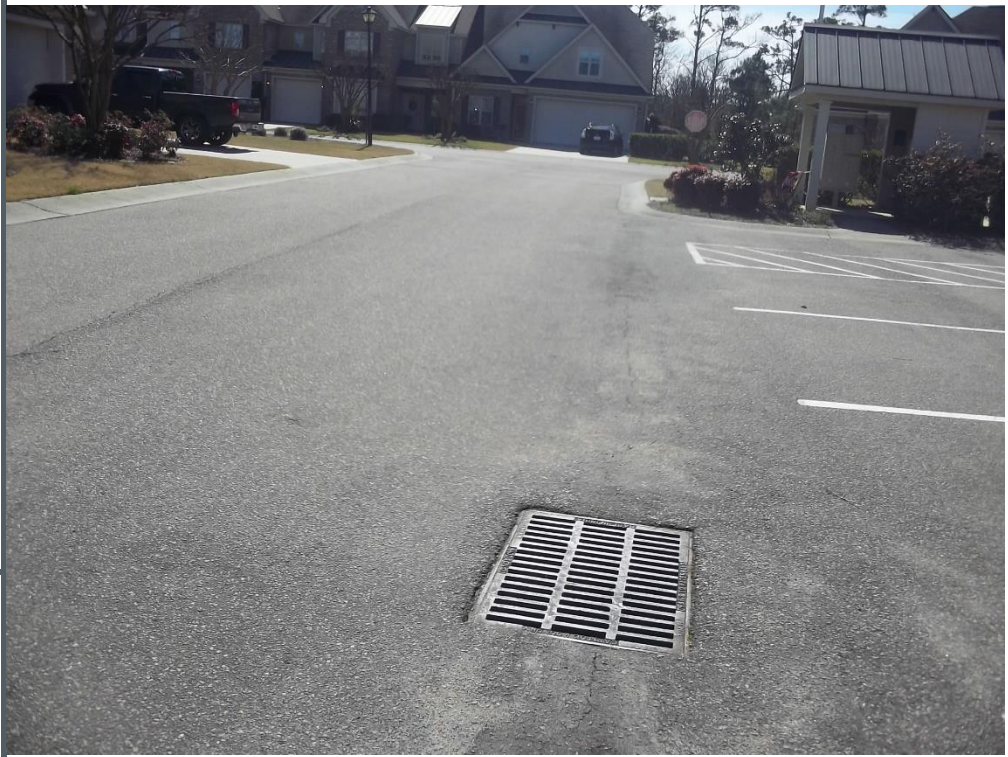
Photo No.
37

Large stormwater catch basin in asphalt street

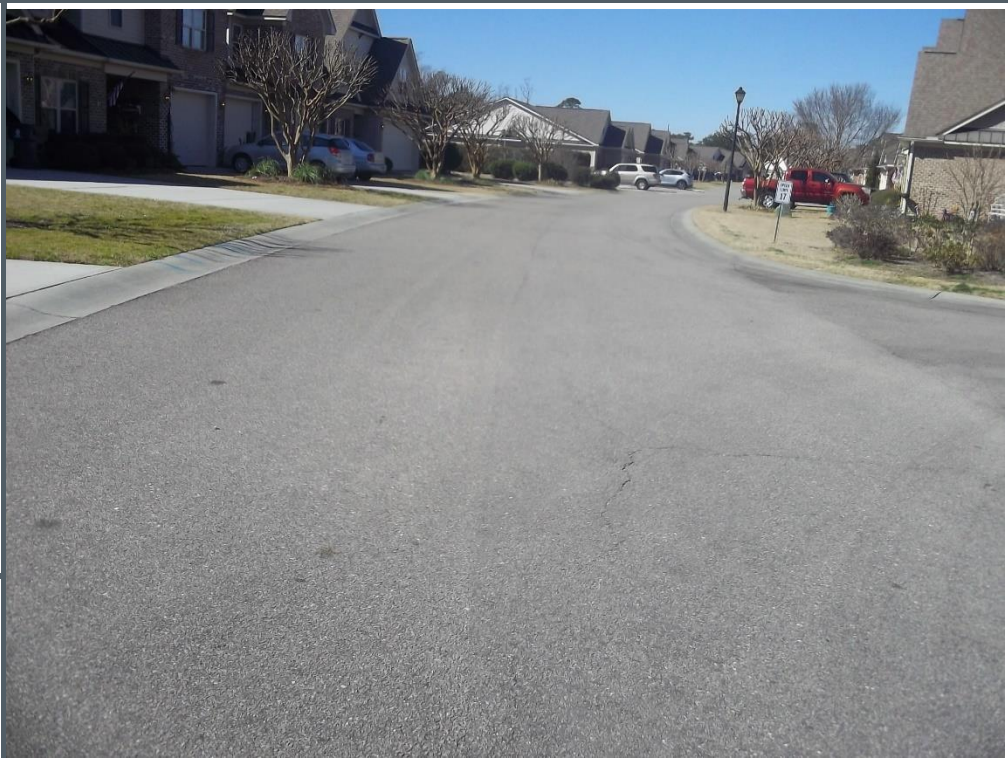
Photo No.
38

Limited longitudinal cracking was observed in sections of the asphalt paving. Although we often recommend periodic crack filling and seal coat applications on low-speed asphalt paving; per discussions with the Board, the Association does not anticipate completing reseal projects on these streets.

View of typical asphalt condition with minor cracking

Assuming sectional repairs of the paving are completed in the interim, we estimate the asphalt paving to have a remaining useful life of approximately 10-12 years prior to resurfacing. Resurfacing would include full depth repairs of sections of paving as needed, milling to remove sections of paving to maintain adequate drainage profiles, followed by surface preparations and the installation of a new 1.5-2” thick wearing layer of asphalt paving over all paved areas. We have allocated funds for resurfacing the asphalt paving in 2033.

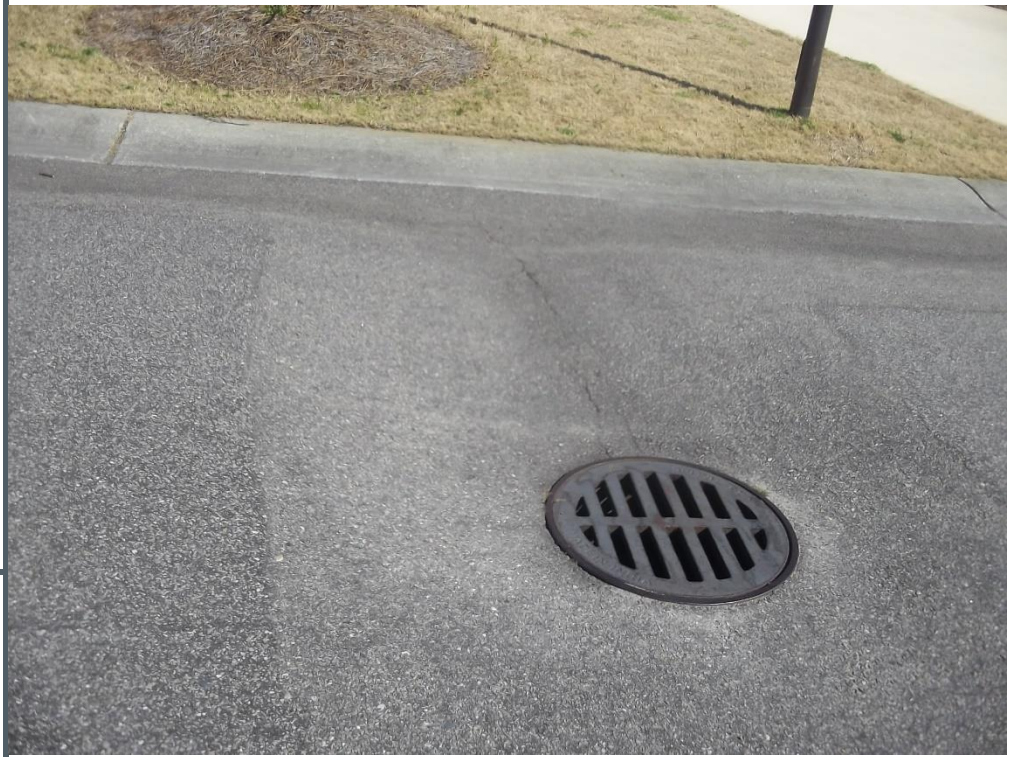
Photo No.
39

Smaller catch basin
(likely added after
original construction) in
private street

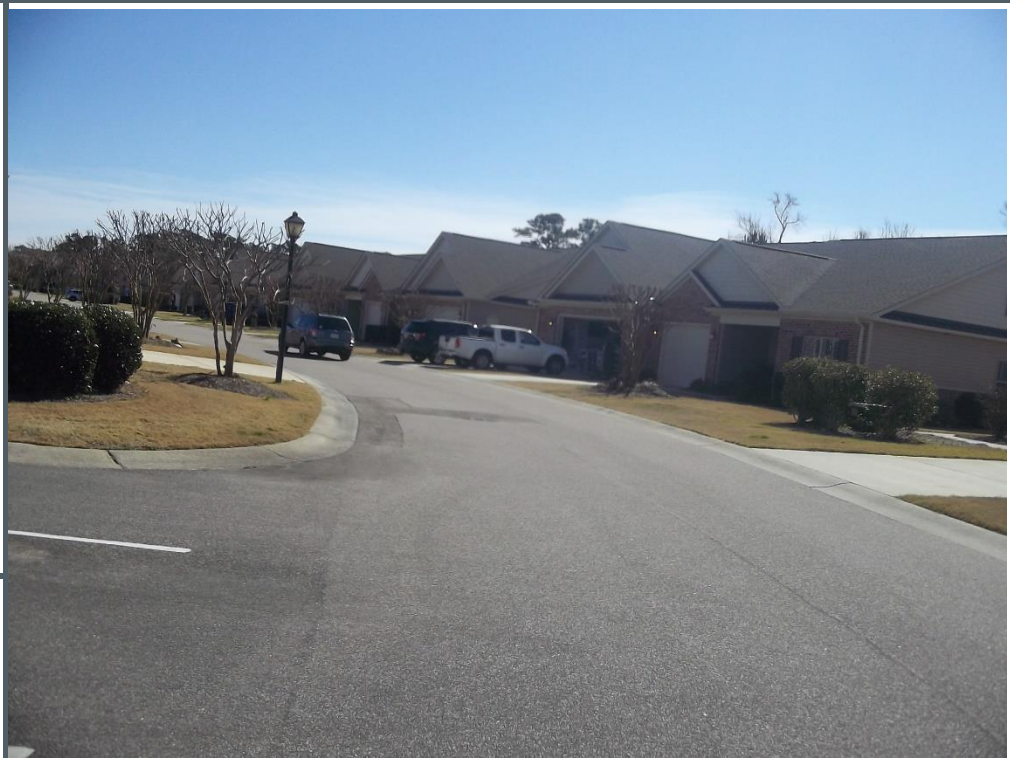
Photo No.
40

The asphalt paving in the parking areas and drive aisles generally appeared to be in fair-to-good condition. We observed sections of paving with concerns including fatigue cracking, depressions and general deterioration in areas of previous water ponding. We also observed previous full depth repairs in small sections of asphalt. We anticipate that additional full depth repairs will be required in the future prior to complete resurfacing. These type repairs would include saw-cutting and removing sections of the asphalt paving, repairing the base course/sub-grade as needed and installing and compacting new asphalt (typically at least 2-inches thick). We have allocated funds in 2026 for full depth repairs of sections of paving.

View of asphalt street
condition and repaired
section at curbing

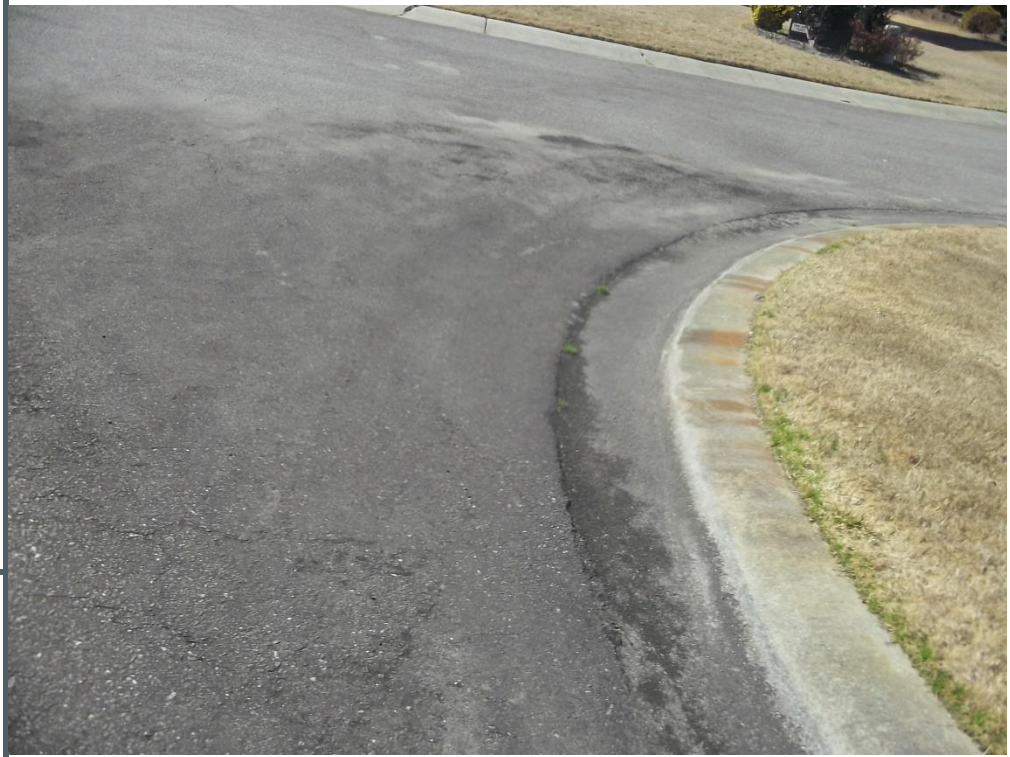
Photo No.
41

View of previous standing water in street near gutter

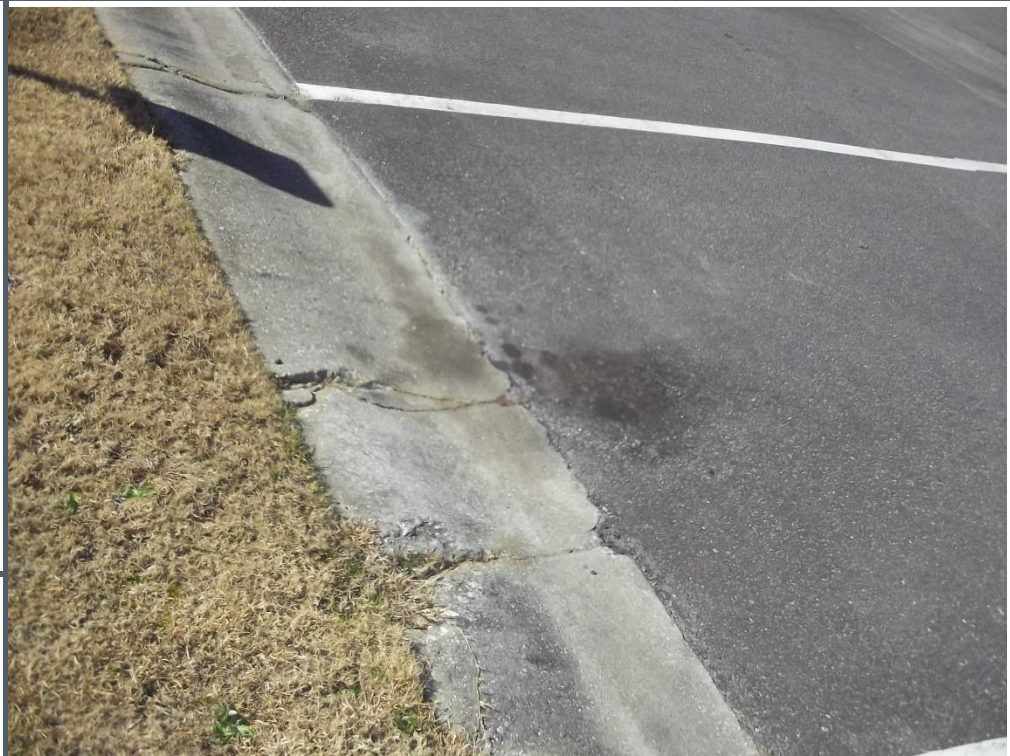
Photo No.
42

More cracking in concrete valley gutter
