# REPLACEMENT RESERVE REPORT FY 2018 SOUTH HARBOUR MASTER POA

# REPLACEMENT RESERVE REPORT

## SOUTH HARBOUR MASTER

SOUTHPORT, NORTH CAROLINA  
December 20, 2017  
Revised July 23, 2018

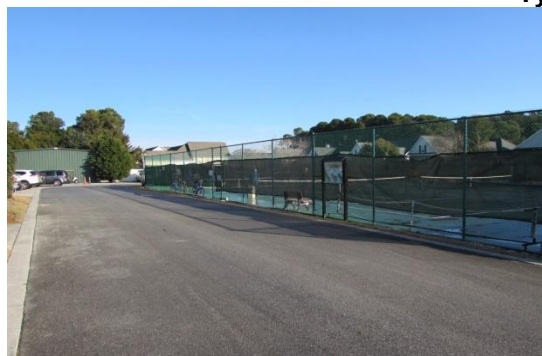
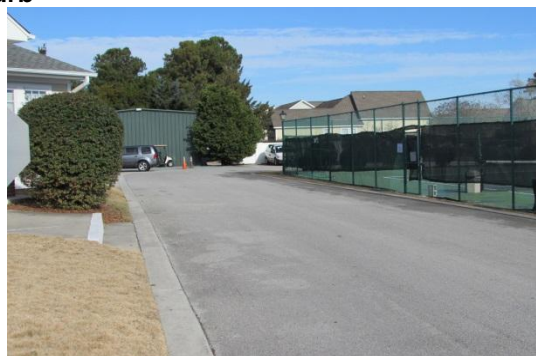
**Typical Concrete Curb**

**Curb.** The Association maintains an inventory of 596 linear feet of concrete curb along the drive at the clubhouse. There are no gutters. All components have been well maintained and are in average to good condition. Any problems noted are in the form of minor cracks, spalling, or settlement that can be repaired by continued periodic replacement of broken sections. The Analyst looked for the following types of defects:

- Cracking. There are no multiple sections of the curb that are cracked.
- Heaving/Settlement. No sections of the curb have heaved or settled relative to their adjacent sections, creating trip hazards.

Because it is highly unlikely that all of the community's concrete curb sections will fail and require replacement in the period of the study, we have programmed funds for the replacement of 60 percent of the inventory and spread those funds over a 60-year timeframe to reflect the incremental nature of this work. This approach assumes a failure rate of one percent per year.

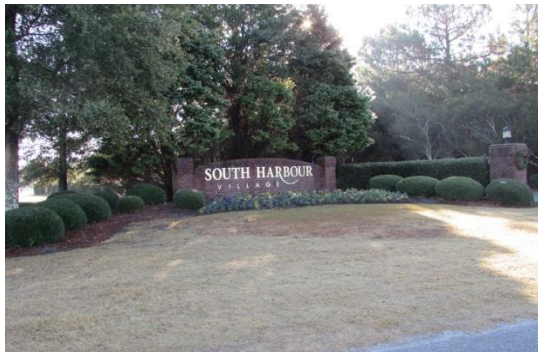
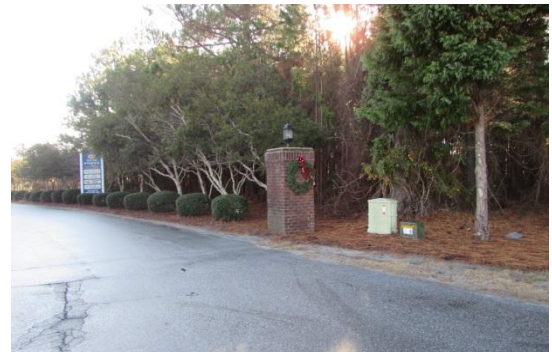
**Entrance Monuments and Brick Column**

Periodic tuckpointing of these joints and replacement of damaged brick is required to extend the life of the wall. Unless the wall is damaged by settlement, this work is typically not required until the wall is approximately 35-40 years old.

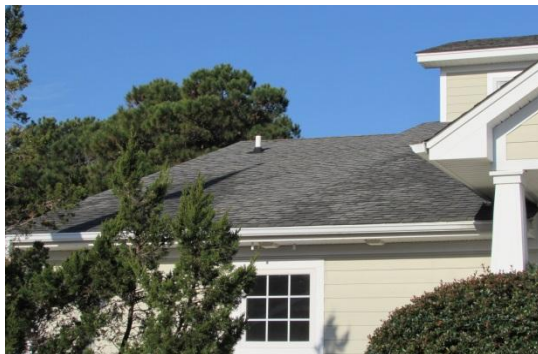
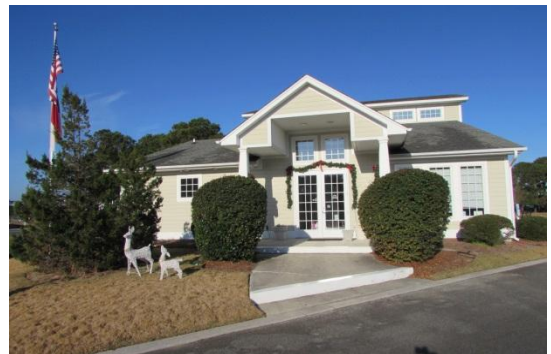
**Asphalt Shingle Roofing.** The asphalt shingle roof on the clubhouse is in good condition. We have estimated the remaining useful life of the roof based on the conditions seen at the site as well as the age of the roof. We have assumed that when the roof eventually will require replacement, all roofs will be replaced with 25-year roofs. We have assumed that the gutters and downspouts will be replaced when the roofs are replaced.

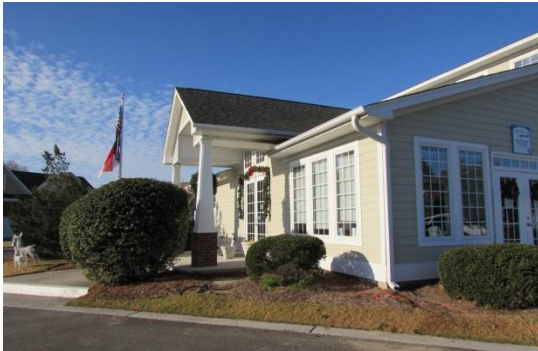
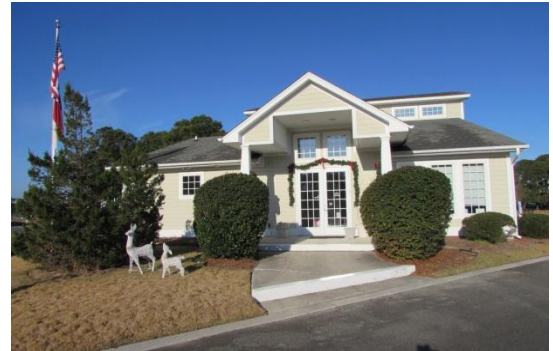
Club House

**Windows.** The windows in the clubhouse are the responsibility of the Association. The existing windows are dual glazed units with aluminum frames. The windows date to the original construction and are approximately 12 years old. The average service life for windows of this type is 35 years. The windows are in good condition.

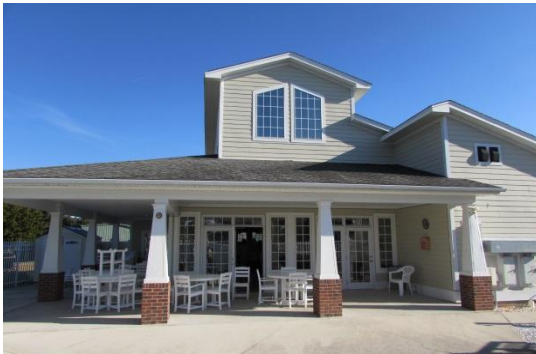
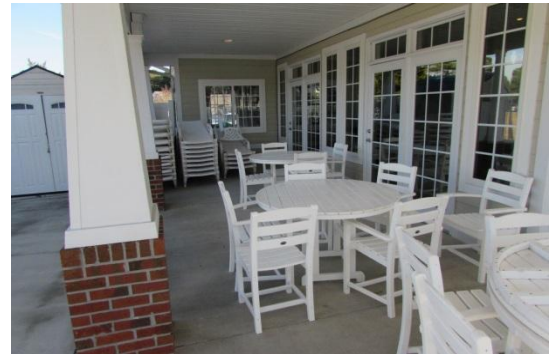
**Rear Views of Club House**

**Doors.** The pump rooms have metal doors that are in good condition. Metal doors are subject to rust especially around the pool chemicals. The clubhouse doors are double French with glass inserts and single doors with glass inserts and are all in good condition.

**Exterior Lighting.** The clubhouse exterior lighting is in good condition. We have provided an allowance for replacement every fifteen years.

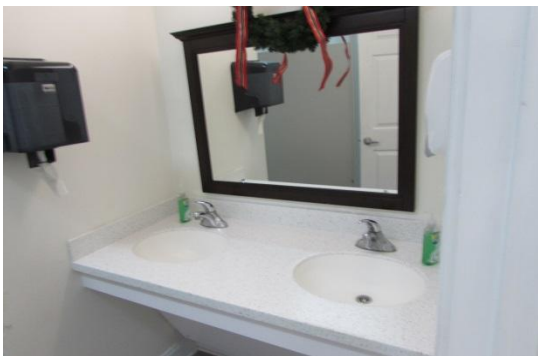
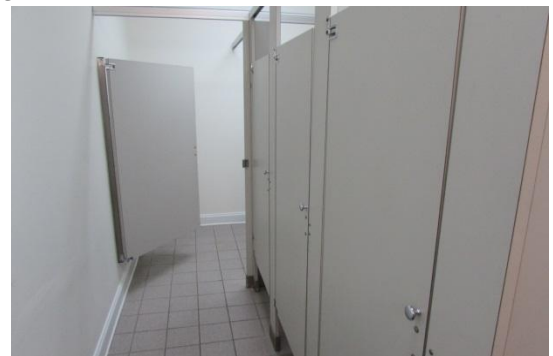
**Typical Restrooms**

**Restrooms.** The two restrooms in the clubhouse that are shared with the pool are in good condition. We have provided an allowance for the renovation of all three rooms.

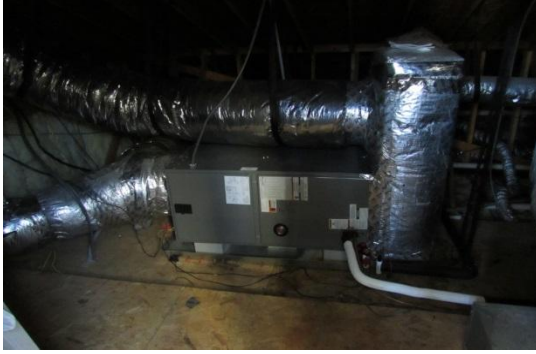
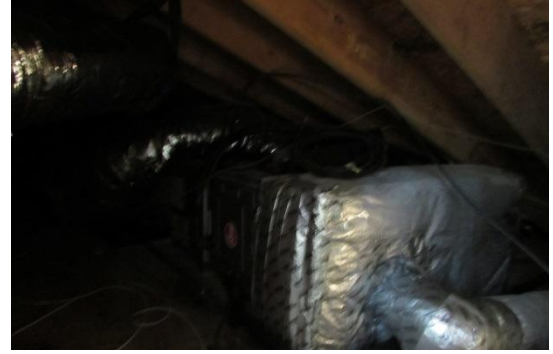
### HVAC SYSTEM INSTALLED IN ATTIC - FURANCE and AIR HANDLER

**Heat Pumps.** There are three heat pumps that serve the building. We have included two items in the Reserve Analysis for the heat pumps: the heat pump system and the system's compressor. For the system, we have assumed a service life of 30 years. For the system's compressor, we have assumed a service life of 15 years. Per the property manager, all three heat pumps have been replaced.

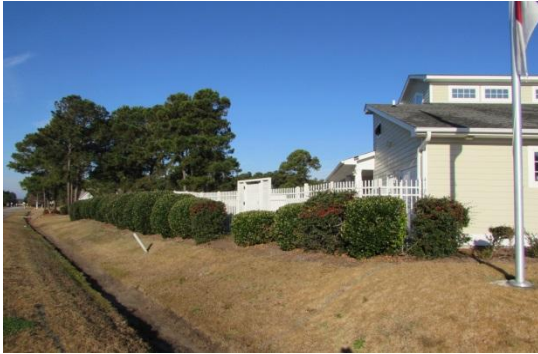
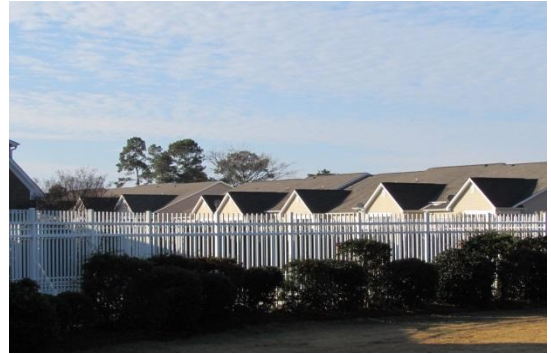
**Metal Fence Around Pool Perimeter**

**Fencing.** The Association maintains a metal fence around the pool that was installed in 2016 and is in good condition. Fencing systems have a large number of configurations and finishes that can usually be repaired as a maintenance activity by replacing individual components as they become damaged or weathered.

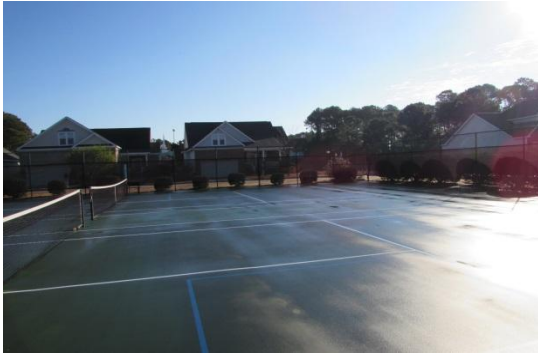
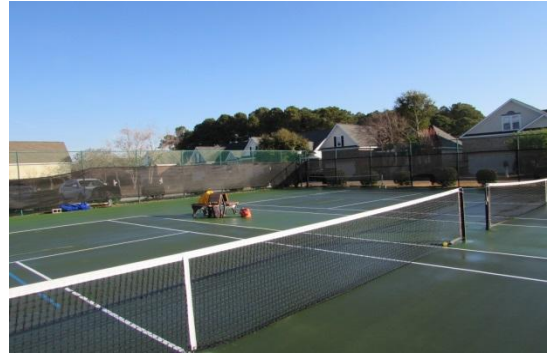
Tennis Courts, Fence and Wind Screen

**Tennis Courts.** The community maintains two tennis courts. The overall condition of these courts is good.

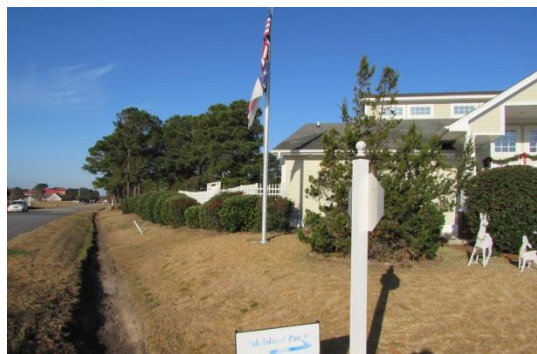
**Flagpole.** There is a metal flagpole located near the entrance to the clubhouse. The flagpole appears to be in average condition.
