# REPLACEMENT RESERVE REPORT FY 2018 SOUTH HARBOUR MASTER POA

# REPLACEMENT RESERVE REPORT

## SOUTH HARBOUR MASTER

SOUTHPORT, NORTH CAROLINA  
December 20, 2017  
Revised July 23, 2018

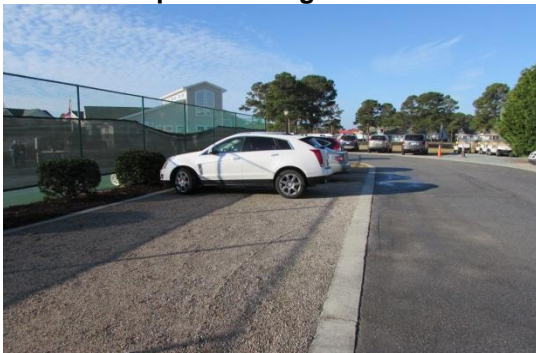
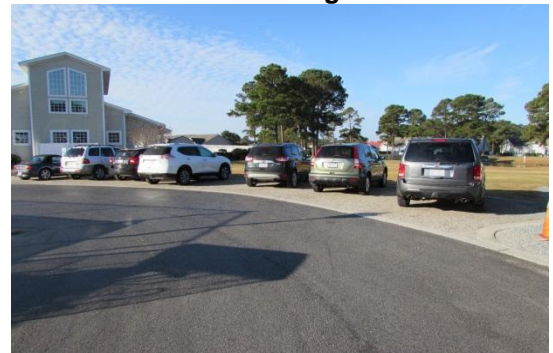
**Asphalt Paving near the Tennis Courts and Club House. Note Gravel Parking Areas.**

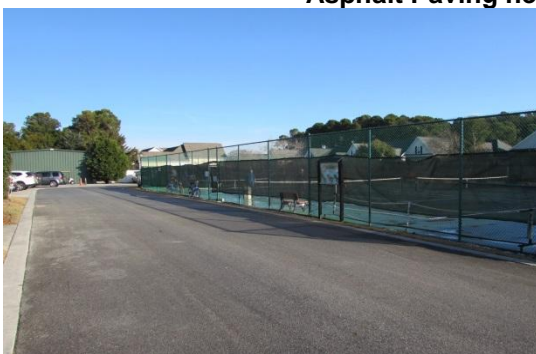
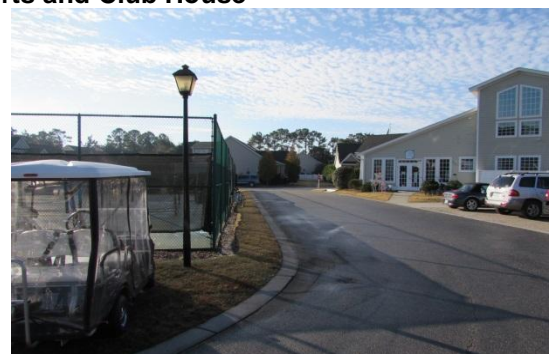
**Asphalt Paving near the Tennis Courts and Club House**

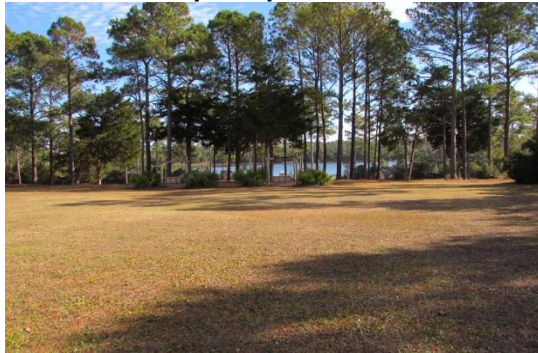
**Park Open Space Area**

**Park Features.** The park near the intercoastal waterway was formerly the site of tennis courts. However, over time, the courts deteriorated and were removed to develop the park site. The park includes stone walk, steps frame with PTW, swings of PTW and benches of composite material. All features are in good condition. We have provided appropriate funding for the features replacement.

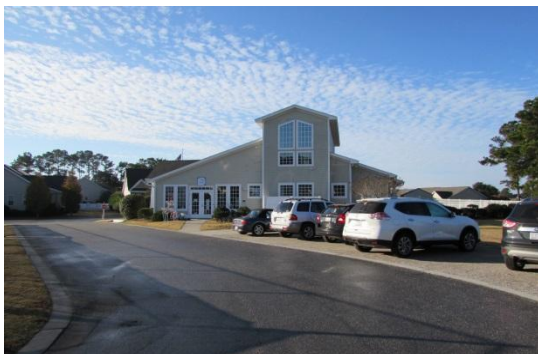
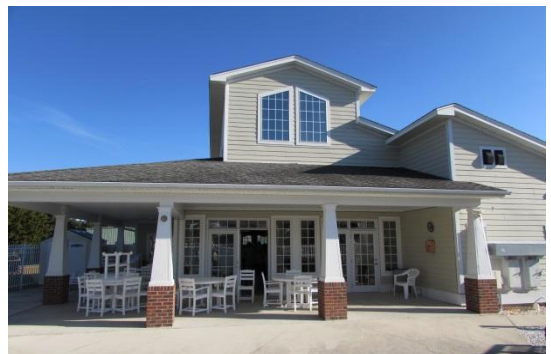
**Club House**

**Gutters and Downspouts.** The Club House has aluminum gutters and downspouts. The gutters and downspouts are in average condition.

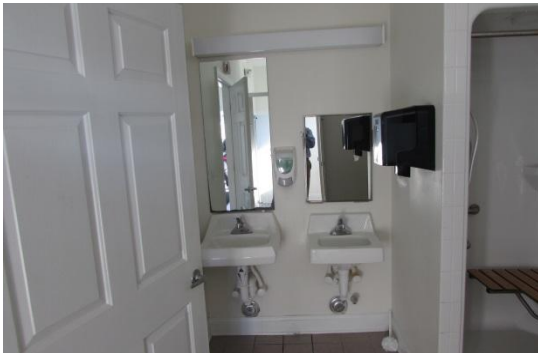
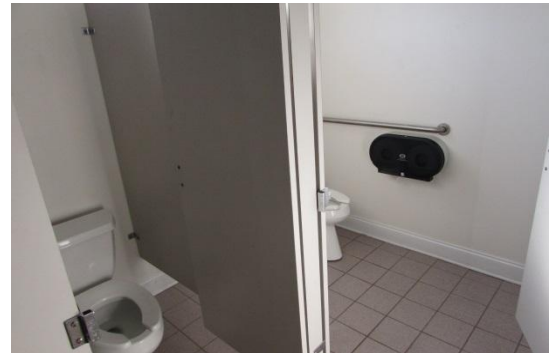
**Typical Restrooms**

**Restrooms.** The two restrooms in the clubhouse that are shared with the pool are in good condition. We have provided an allowance for the renovation of all three rooms.

- **Restrooms.** We have included two items for the restrooms: the fixtures and the epoxy floor finish. Both are in good condition.

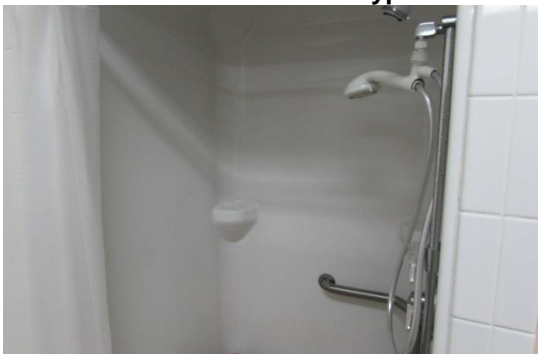
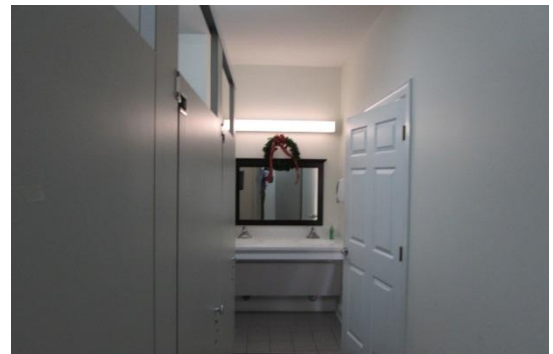
**Typical Restrooms with Fiberglass Shower Unit**

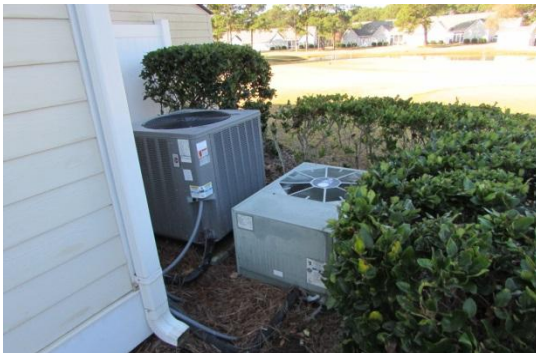
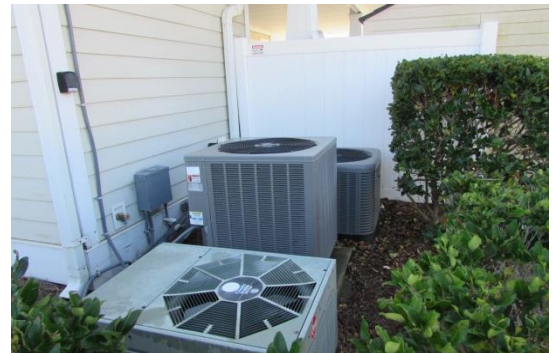
### HVAC SYSTEM

**Heat Pumps.** There are three heat pumps that serve the building. We have included two items in the Reserve Analysis for the heat pumps: the heat pump system and the system's compressor. For the system, we have assumed a service life of 30 years. For the system's compressor, we have assumed a service life of 15 years. Per the property manager, all three heat pumps have been replaced.

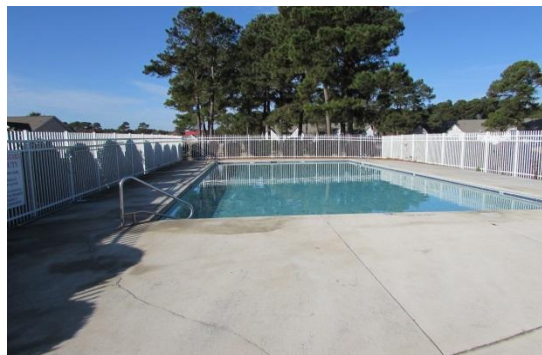
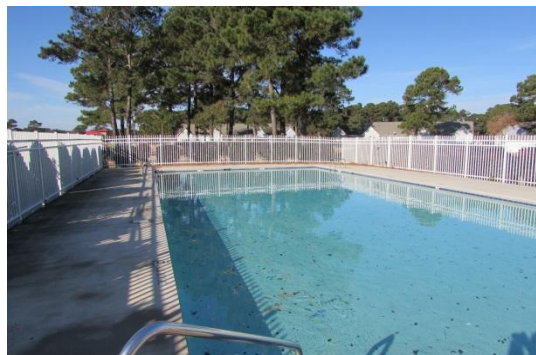
### SWIMMING POOL

- **Pool Shell.** The shell for the swimming pool is currently being recoated and repaired. Pool shells normally have a finite life of approximately 45 years. At that time, it may not be necessary to replace the entire structure. However, it is prudent to anticipate a major expenditure for replacement of underground lines and sections of the pool. Based on our research, we have found it to be prudent to program \$85.00 per square foot of pool surface to cover these needs.

- **Pool Deck.** The pool has a concrete deck. The overall condition of the deck is good. Because it is highly unlikely that all the community's concrete pool deck sections will fail and require replacement at the same time, we have divided the deck into three equal components in the Reserve Analysis and have spread their replacement over an 18-year period.

- **Whitecoat.** The pool whitecoat is currently being reinstalled and should be in good condition when the pool renovations are completed. We have assumed a service life of eight to ten years for the pool whitecoat.

- **Waterline Tile.** The waterline tile is in good condition. We have assumed that the waterline tile will be replaced or restored when the pool whitecoat is being restored.

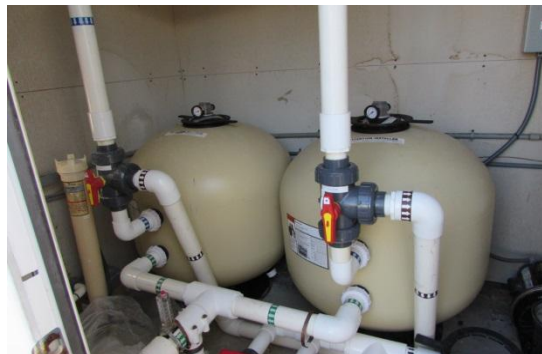
POOL FILTERS

- **Pump and Filter System.** The filter system is in average operating condition. A new pump was installed in 2017. We have assumed a service life of 20 years for the filter system, and 10 years for the pump.

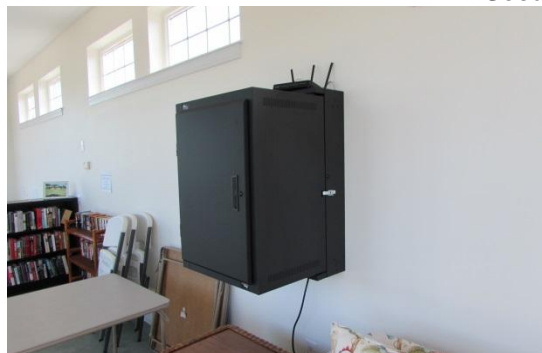
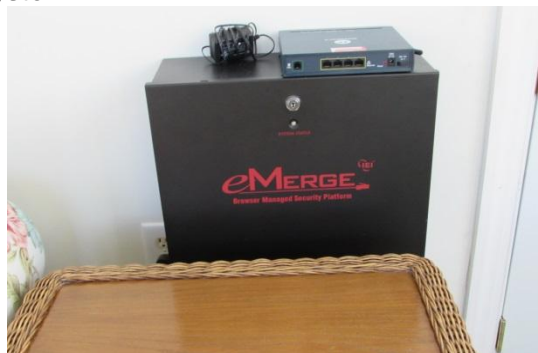
Security Monitoring System

**Security System.** The Association maintains a video system with recording capability with cameras located in various areas along the exterior of the clubhouse.

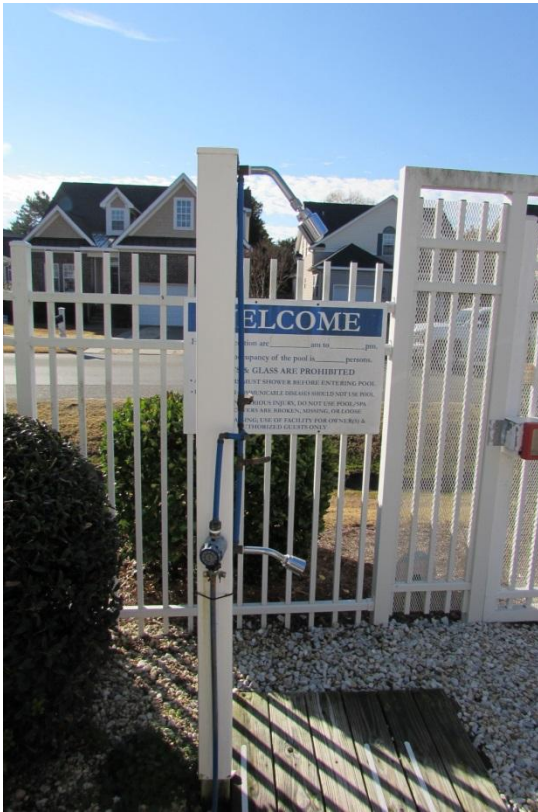
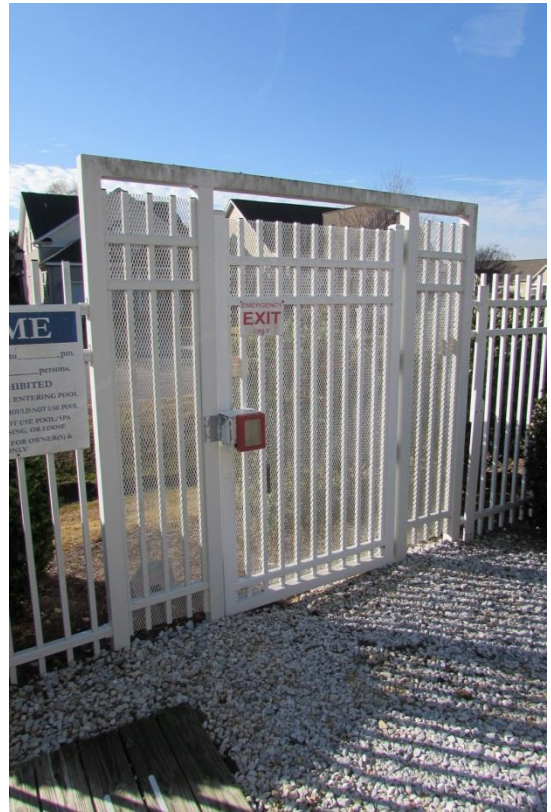
- **Access System.** The building is an access-controlled facility with electrically operated doors activated by a card swipe system. Systems of this type typically have a service life of 15 years. Beyond that point, it becomes difficult to find replacement parts or companies that can service the system. Additionally, changes in technology help render the systems obsolete. For these reasons, we have assumed a service life of 15 years for the system.

**Metal Entrance Gate with Swipe Card Access and Outdoor Shower**

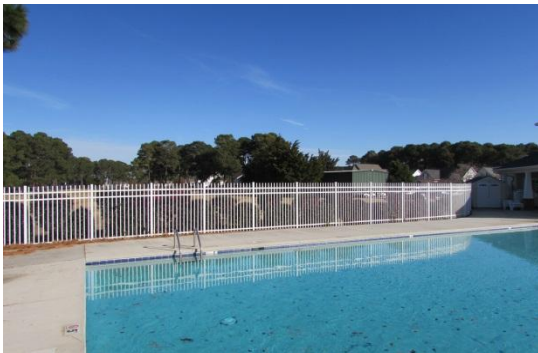
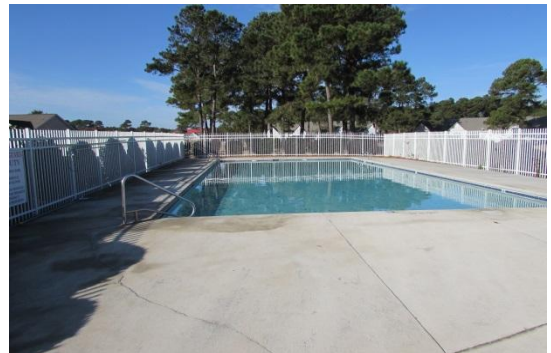
**Fencing.** The Association maintains a metal fence around the pool that was installed in 2016 and is in good condition. Fencing systems have a large number of configurations and finishes that can usually be repaired as a maintenance activity by replacing individual components as they become damaged or weathered.

Fence posts can have an extended useful life if these simple maintenance activities are performed. If left unattended, the pressure from expansive post rust can crack and damage the supporting material.

**Metal Fence Around Pool Perimeter**

As part of normal maintenance, we recommend the following:

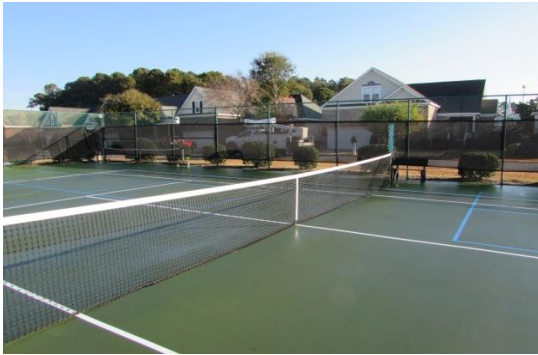
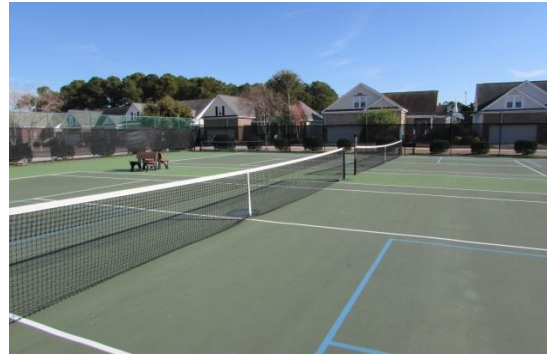
Tennis Courts

**Tennis Courts.** The community maintains two tennis courts. The overall condition of these courts is good.

- Asphalt Pavement (base layer). We have assumed a service life of 20 to 30 years for the asphalt base layer.
- Color Coat (surface layer). Annual cleaning is recommended to maintain the surface of the court. The base of a tennis court is subject to cracking and low spots known as “birdbaths” that can occur from weather and earth movement. A program to address cracks as they appear will help to prolong the useful life of the color coat. We have assumed a service life of five to ten years for the color coat. The courts have recently been color coated.

Fencing. The Association maintains metal fencing that is in generally in average condition. Fencing systems have a large number of configurations and finishes that can usually be repaired as a maintenance activity by replacing individual components as they become damaged or weathered.

We have assumed that the fencing will be replaced when the asphalt pavement is replaced. Posts and fencing should be inspected, repaired, and painted as needed to prolong their economic life. Periodic inspection of the posts, gates, hinges, and latches is also recommended, and it is important that posts and footings be protected to prevent soil erosion. In addition, care should be taken so that damage from string trimmers is minimized.

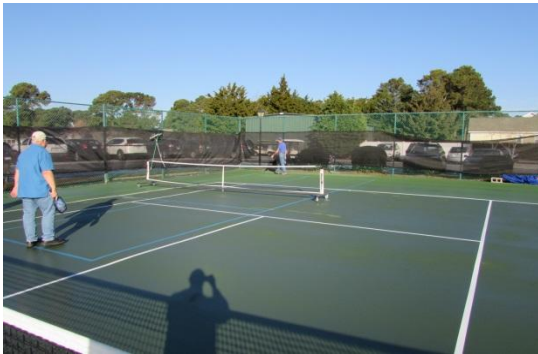
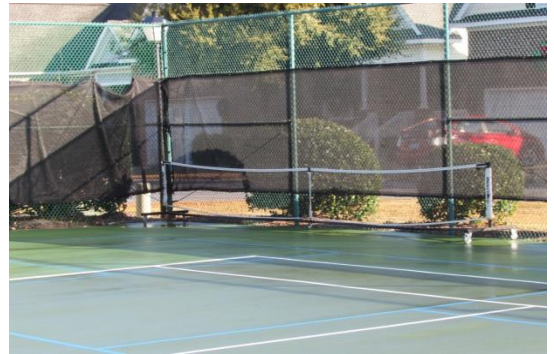
Tennis Courts and Pickle Ball Nets

- Net Posts. We have assumed that the new posts will be replaced when the asphalt pavement is replaced.
- Wind Screen. We have assumed a service life of five years for windscreens.
- Lighting System. No exterior lighting.
